ST JAMES FEMA REPAIRS

3617 GULFWAY DRIVE

DRAWINGS SHEET TITLE
COVER SHEET

DRAWINGS SHEET TITLE	FIRST FLOOR PLAN - MAIN BUILDING
SHEET NUMBER	A101
PROJECT NUMBER	21074

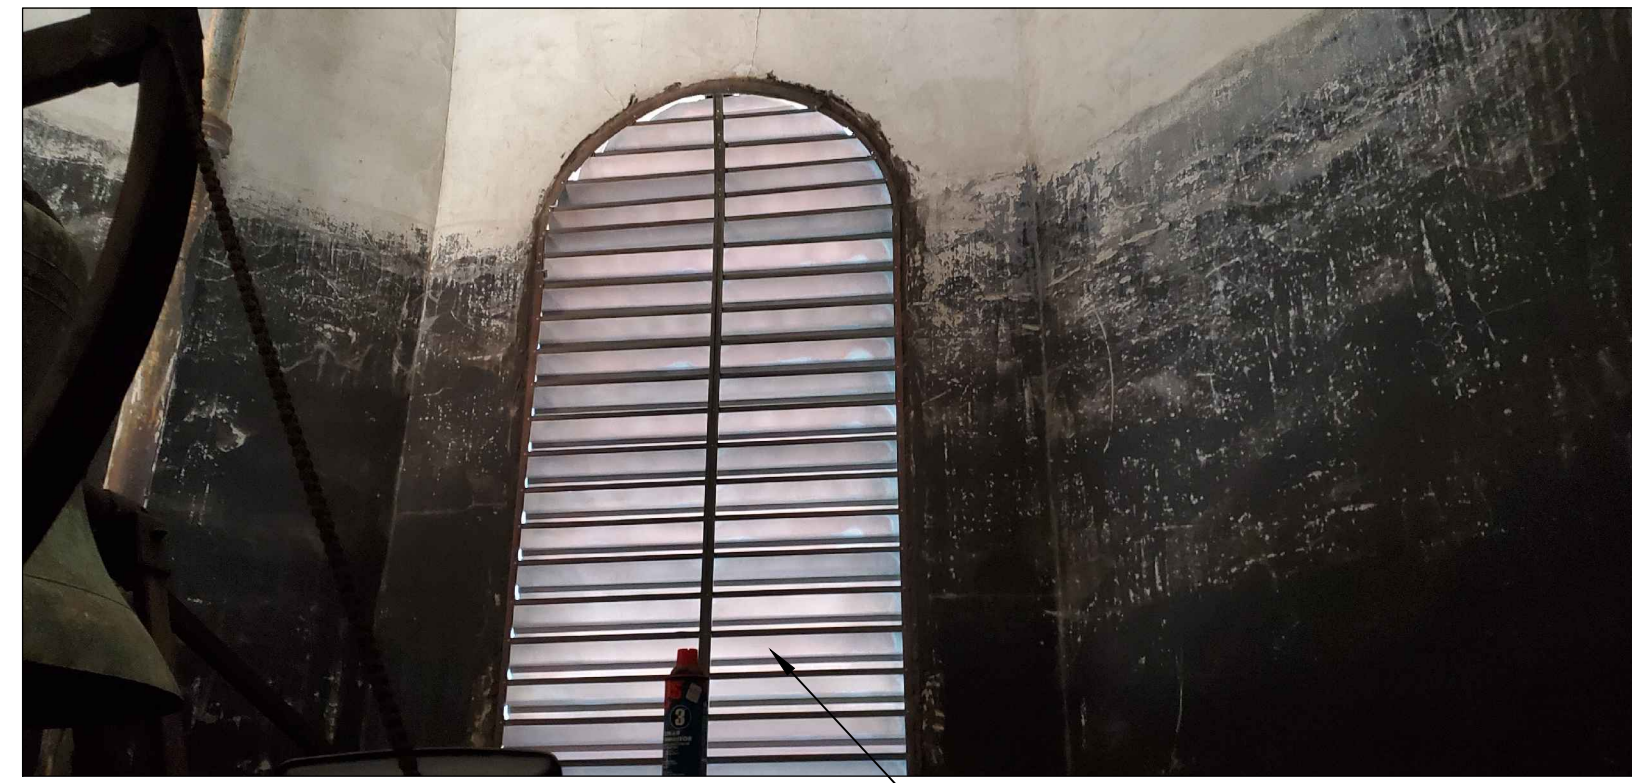
B-A

- B-1 (SEE A102 SOUND ROOM (SECOND FLOOR))
- B-2 1,140 SF OF PLASTER WALLS(3 COATS OVER METAL LATH), OCTAGON SHAPED TOWER, AREA 15' WIDE X 19' HIGH, WATER AND MOLD SATURATION TO PLASTER WALLS CAUSED BY WIND DRIVEN RAIN ENTERING THROUGH LOUVERS IN THE BELL TOWER
PHOTO: B-A, B-B, B-C
FINAL SCOPE - REMOVE AND REPLACE 1,140 SF OF PLASTER WALLS(3 COATS OVER METAL LATH)
- B-3 225 SF CONCRETE OCTAGON SHAPED TOWER - AREA 15' WIDE, WATER AND MOLD SATURATION TO FLOOR CAUSED BY WIND DRIVEN RAIN ENTERING THROUGH LOUVERS IN THE BELL TOWER.
PHOTO: B-B
FINAL SCOPE - PRESSURE WASH 225 SF CONCRETE FLOOR
- B-4 1,140 SF OF PAINT WALLS, OCTAGON SHAPED TOWER, AREA 15' WIDE X 19' HIGH, WATER AND MOLD SATURATION TO PLASTER WALLS CAUSED BY WIND DRIVEN RAIN ENTERING THROUGH LOUVERS IN THE BELL TOWER
PHOTO: B-A, B-B
FINAL SCOPE - REPLACE 1,140 SF OF PAINT

(ALTERNATE #3)
B-5 REMOVE EXISTING LOUVERS
PHOTO: B-A, B-D, B-E
FINAL SCOPE - REPLACE LOUVERS WITH MIAMI DADE COUNTY QUALIFIED WIND-DRIVEN LOUVER. GREENHECK EHH-601D WITH STAINLESS STEEL INSECT SCREEN AND VCD-40 DAMPER. FLANGE/SLEEVE INSTALLATION. MILL FINISH

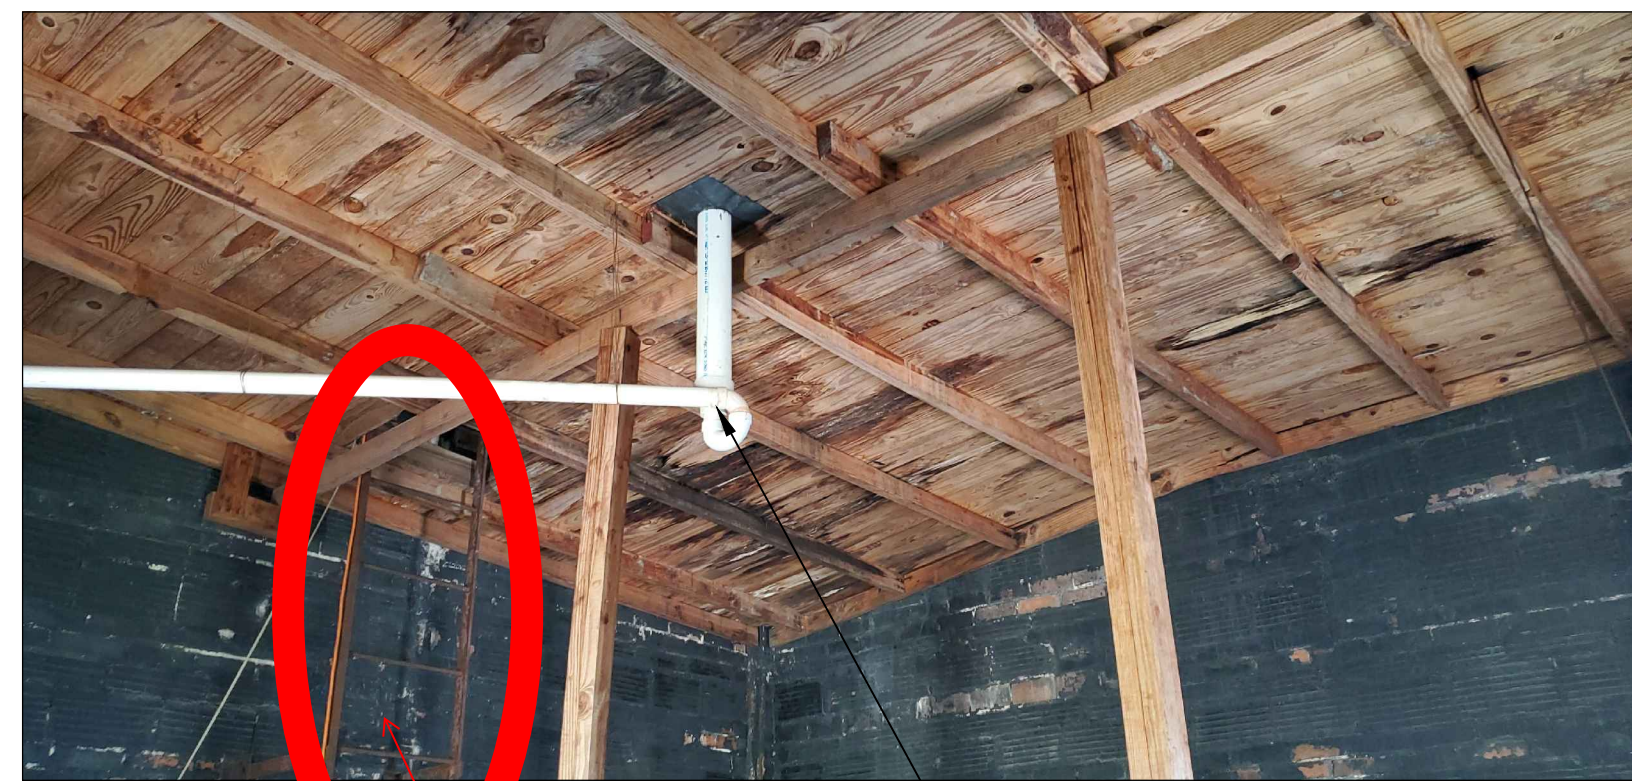
- B-1 225 SF OF WOOD DECK CEILING, 15' X 15' AREA WOOD DECK CEILING, WATER AND MOISTURE DAMAGE TO CEILING CAUSED BY WIND DRIVEN RAIN ENTERING THROUGH STEEPLE ROOF ON THE BELL TOWER (A103) PHOTO: SG-A (A103) FINAL SCOPE - REMOVE AND REPLACE 225 SF OF WOOD DECK WITH LIKE

SG-1 289 SF OF WOOD DECKING CEILING, 17' X 17'-2" X 4' AND 2' X 6' WOOD DECK, WATER AND MOLD SATURATION TO WOOD CEILING CAUSED BY WIND DRIVEN RAIN LEAKING THROUGH THE ROOF
PHOTO: SG-A
FINAL SCOPE - REMOVE AND REPLACE 289 SF OF 2' X 4' AND 2' X 6' WOOD DECK CEILING

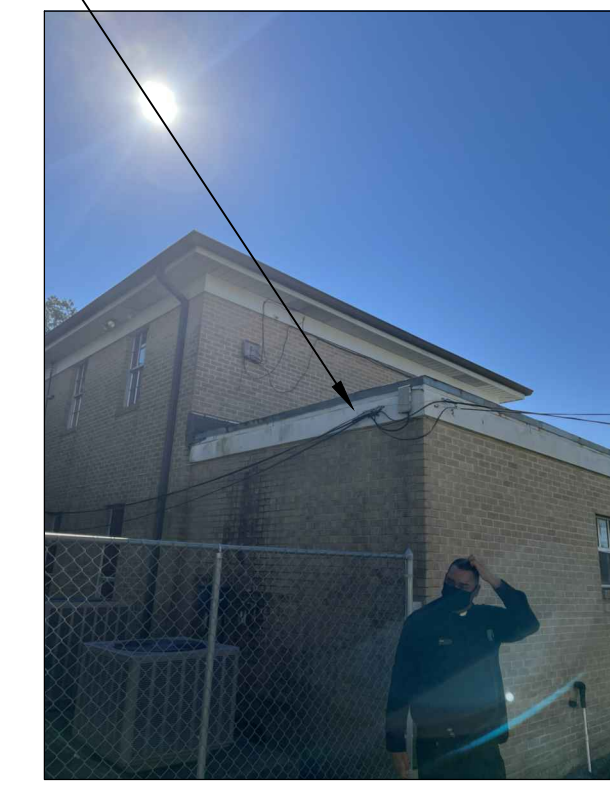
- E-1 METAL FLASHING 80 LF LONG, SEPARATION OF FLASHING FROM ROOF CAUSED BY HIGH WINDS.
PHOTO: E-A, A-B, E-C
FINAL SCOPE - SEE SHEET A110 CONVENT FOR SCOPE OF REPAIR

REMOVE FLASHING/COUNTER-FLASHING. SEE SHEET A110 FOR SCOPE OF REPAIR

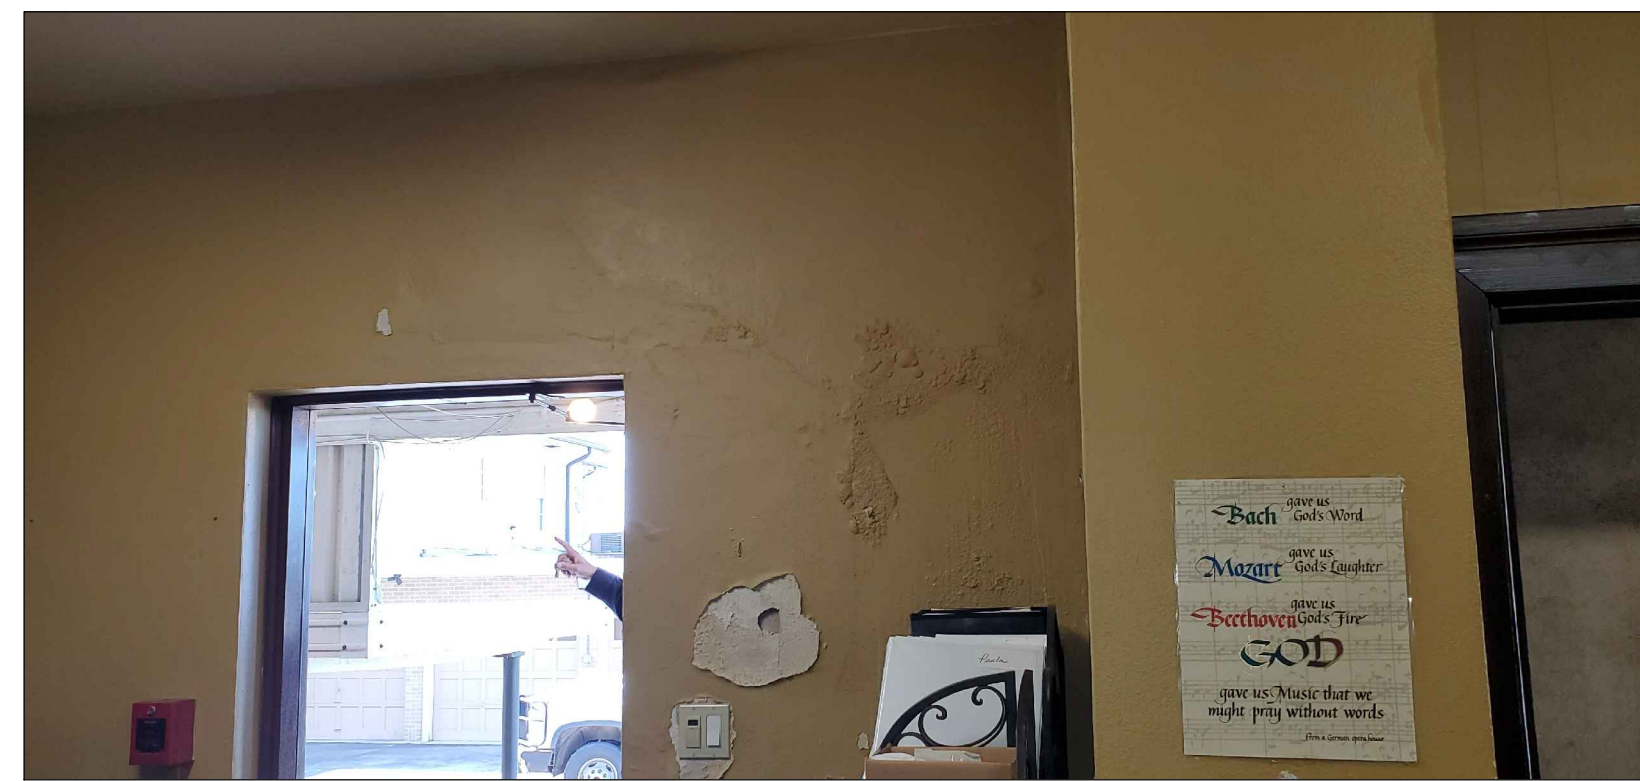
EA-1 WATER AND MOISTURE DAMAGE TO WALLS AND CEILINGS CREATING MOLD AND PEELING PAINT CAUSED BY WIND AND DRIVEN RAIN LEAKING THROUGH ROOF
 PHOTO: CH-A
 FINAL SCOPE - REMOVE LOOSE PAINT AND RE-PAIN WALL AND CEILING

- CH-1 690 SF OF PLASTER WALLS, 65.24' LONG X 10.58' HIGH, WATER AND MOISTURE WATER AND MOISTURE DAMAGE TO WALLS CREATING MOLD AND PEELING PAINT CAUSED BY WIND DRIVEN RAIN ENTERING THROUGH LOUVERS ON THE BELL TOWER
 PHOTO: CH-A
 FINAL SCOPE - REMOVE AND REPLACE 690 SF OF PLASTER WALL

- CH-2 690 SF OF PAINT WALLS 65.24' LONG X 10.58' HIGH, WATER AND MOISTURE WATER AND MOISTURE DAMAGE TO WALLS CREATING MOLD AND PEELING PAINT CAUSED BY WIND DRIVEN RAIN ENTERING THROUGH LOUVERS ON THE BELL TOWER
 PHOTO: CH-A
 FINAL SCOPE - PAINT WALLS

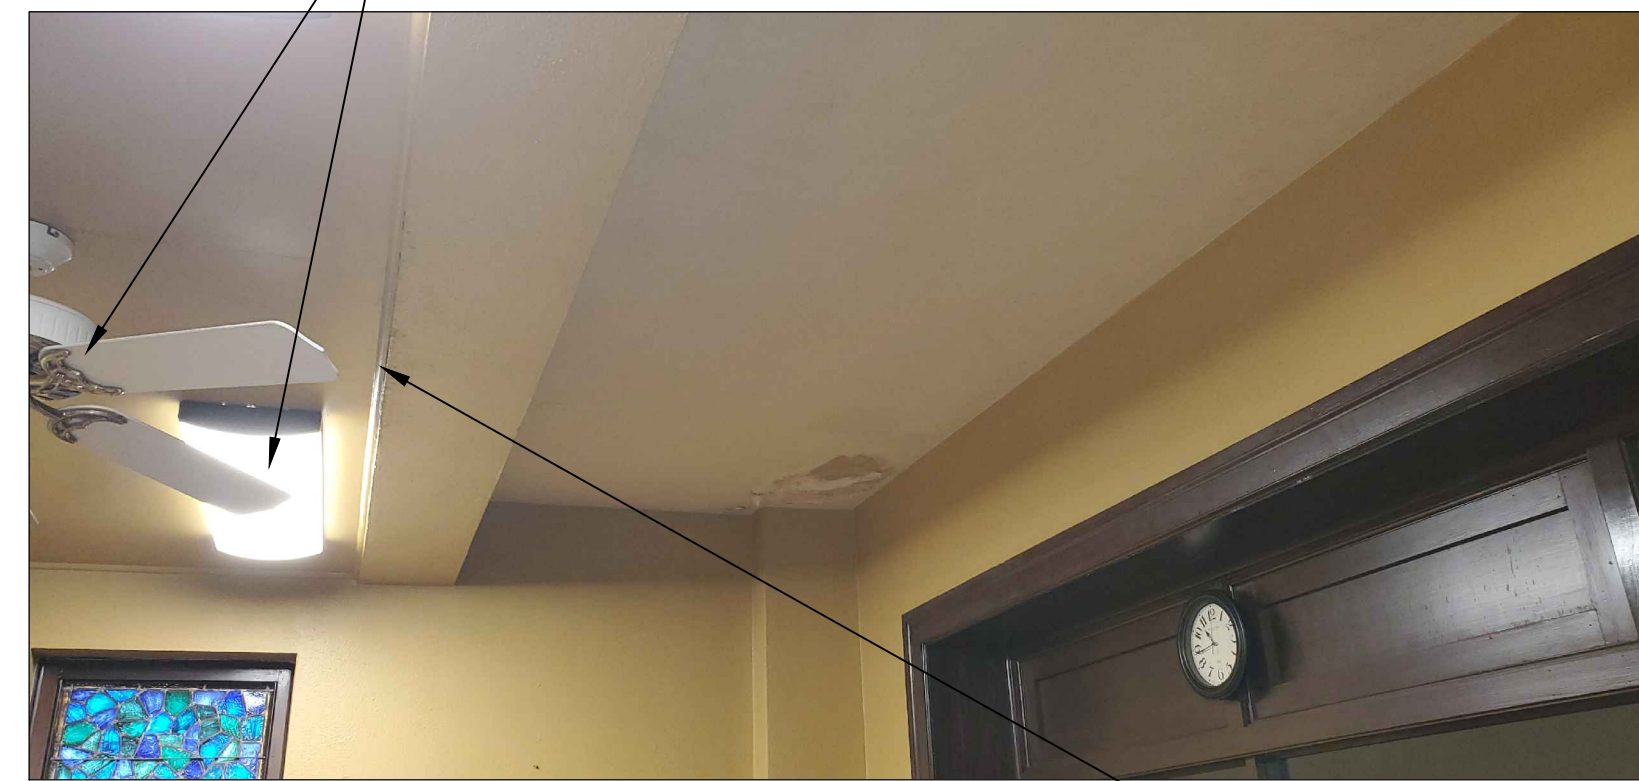
CH-B

- CH-3 370 SF OF PLASTER CEILING, 17.58' LONG X 13.42' WIDE, + 13.38' LONG X 10' WIDE, WATER AND MOISTURE WATER AND MOISTURE DAMAGE TO WALLS CREATING MOLD AND PEELING PAINT CAUSED BY WIND DRIVEN RAIN ENTERING THROUGH LOUVERS ON THE BELL TOWER
 PHOTO: CH-B, CH-C, CH-F
 FINAL SCOPE - REMOVE ENTIRE PLASTER CEILING AND REPLACE WITH NEW.

- CH-6 370 SF OF PAINT CEILING, 17.58' LONG X 10.58' HIGH, WATER AND MOISTURE WATER AND MOISTURE DAMAGE TO WALLS CREATING MOLD AND PEELING PAINT CAUSED BY WIND DRIVEN RAIN ENTERING THROUGH LOUVERS ON THE BELL TOWER
 PHOTO: CH-B, CH-C, CH-F
 FINAL SCOPE - PAINT ENTIRE PLASTER CEILING

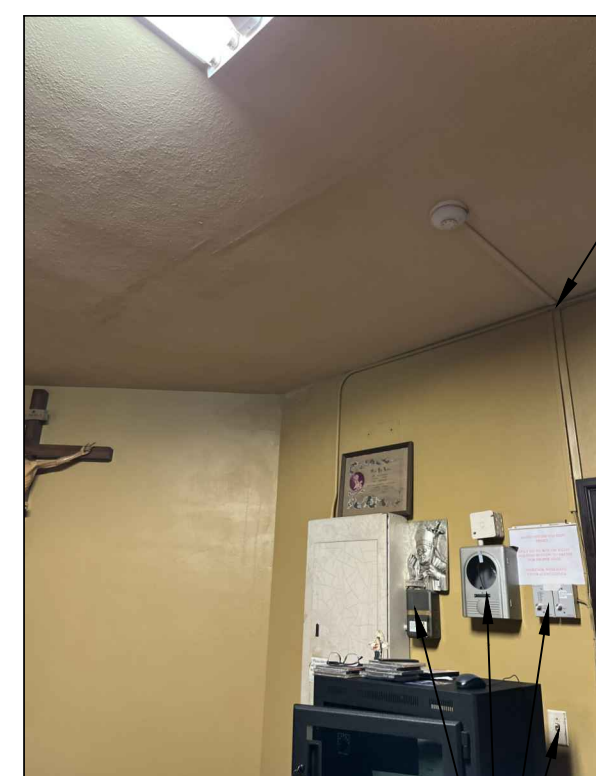
SR-A

- SR-3 160 SF OF PLASTER WALL, 16' LONG X 10' HIGH, WATER AND MOISTURE DAMAGE TO CEILING CREATING MOLD AND PEELING PAINT CAUSED BY WIND DRIVEN RAIN LEAKING THROUGH ROOF
 PHOTO: SR-A, SR-B
 FINAL SCOPE - REMOVE AND REPLACE 160 SF PLASTER WALL.

- SR-4 160 SF OF WALL PAINT, 16' LONG X 10' HIGH, WATER AND MOISTURE DAMAGE TO WALL CREATING MOLD AND PEELING PAINT CAUSED BY WIND DRIVEN RAIN LEAKING THROUGH ROOF
 PHOTO: SR-A, SR-B
 FINAL SCOPE - PAINT 160 SF OF WALL

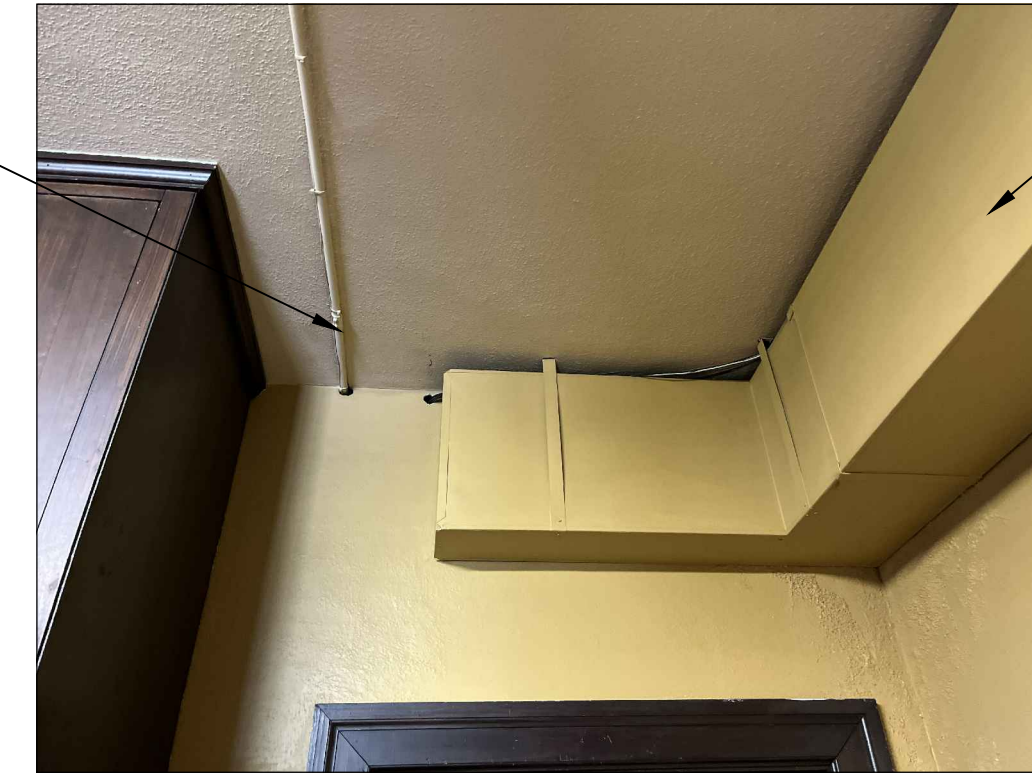
S-E

- S-1 259 SF OF PLASTER CEILING, 16.5' LONG X 15.67' WIDE, WATER AND MOISTURE DAMAGE TO CEILING CREATING MOLD AND PEELING PAINT CAUSED BY WIND DRIVEN RAIN LEAKING THROUGH ROOF
 PHOTO: S-A, S-B, S-C, S-D, S-E, S-F
 FINAL SCOPE - REMOVE AND REPLACE ENTIRE PLASTER CEILING. REMOVE HVAC METAL DUCT, PAINT AND REINSTALL.
- S-2 259 SF OF PAINT CEILING, 16.5' LONG X 15.67' WIDE, WATER AND MOISTURE DAMAGE TO CEILING CREATING MOLD AND PEELING PAINT CAUSED BY WIND DRIVEN RAIN LEAKING THROUGH ROOF
 PHOTO: S-A, S-B, S-C, S-D, S-E, S-F
 FINAL SCOPE - PAINT CEILING

REMOVE AND REINSTALL CONDUIT ONCE PLASTER IS REPLACED AND PAINTED

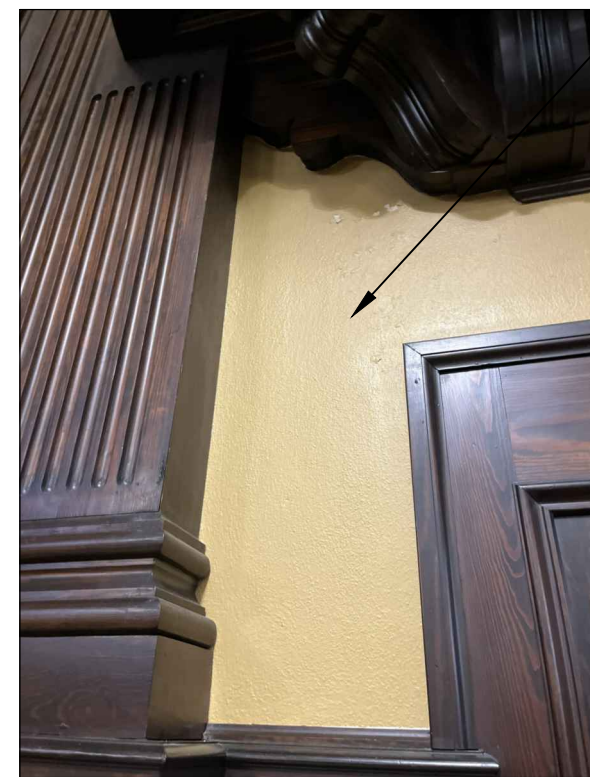
N-A

N-1 WATER AND MOISTURE DAMAGE TO PAINT BELOW WOOD RAILING
 PHOTO: N-A, N-B, N-C
 FINAL SCOPE - REMOVE LOOSE PAINT AND RE-PAIN WALL FROM TOP OF WOOD WAINSCOT TO BOTTOM OF WOOD TRIM

REMOVE LOOSE PAINT. PAINT WALL FROM TOP OF WOOD WAINSCOT TO BOTTOM OF WOOD TRIM

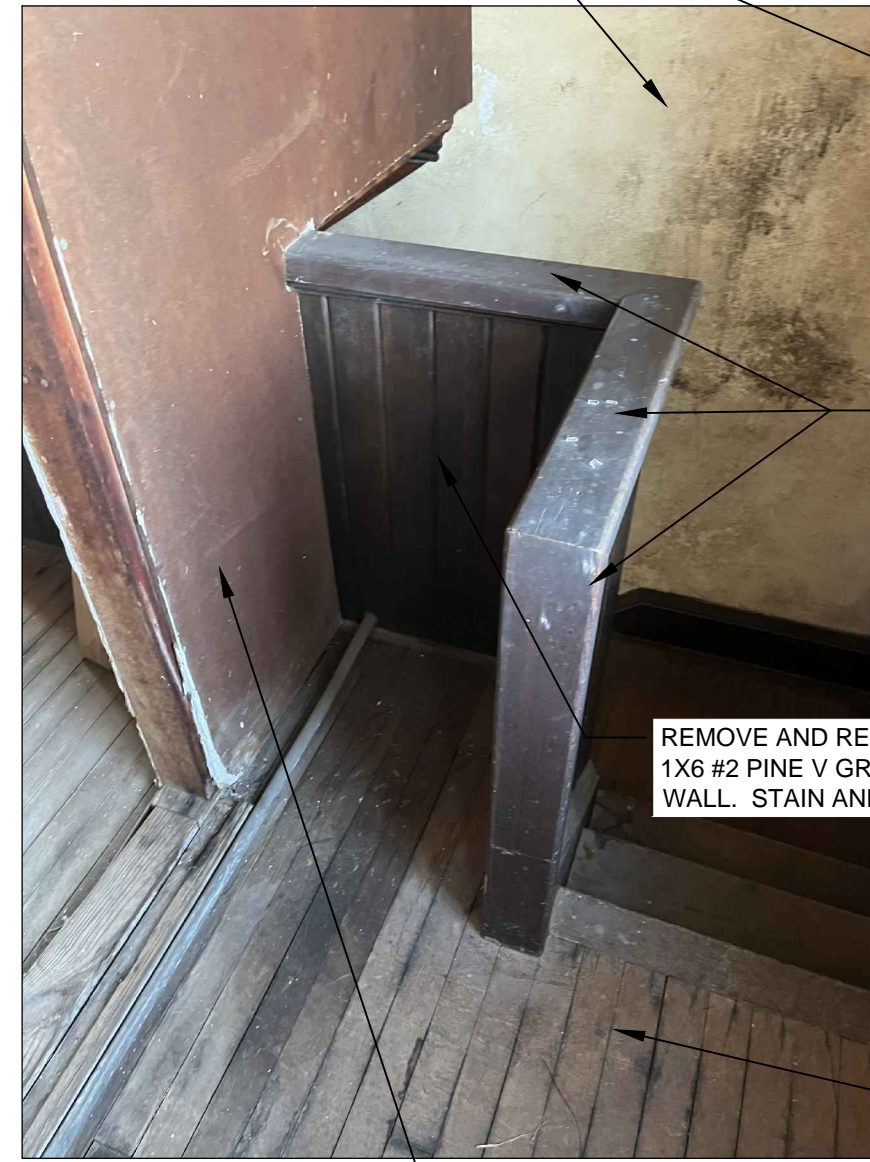
ST-B

- ST-3 256 SF OF 1/2" THICK DRYWALL, 16' LONG X 16' HIGH, WATER AND MOISTURE DAMAGE TO WALL CAUSED BY WIND DRIVEN RAIN ENTERING THROUGH LOUVERS IN THE BELL TOWER PHOTO: ST-B, ST-G FINAL SCOPE - REMOVE AND REPLACE 256 SF OF 1/2" FINISHED DRYWALL

- ST-4 594.3 SF OF PLASTER (3 COATS OVER METAL LATH) WALLS (4 SIDES) 17.92' LONG X 10' HIGH + 4.17' LONG X 16' HIGH + 18.75' LONG X 16' HIGH + 2.42' LONG X 20' HIGH, WATER AND MOISTURE DAMAGE TO WALLS CREATING MOLD AND PEELING PAINT CAUSED BY WIND DRIVEN RAIN THROUGH LOUVERS IN THE BELL TOWER. PHOTO: ST-A, ST-B, ST-C, ST-F FINAL SCOPE - REMOVE AND REPLACE 294.3 SF OF PLASTER WALL

- ST-7 111.35 SF OF OAK FLOORING - CLEAR GRADE, FLOORING, WATER AND MOISTURE DAMAGE TO FLOORING CAUSED BY WIND DRIVEN RAIN ENTERING THROUGH LOUVERS IN THE BELL TOWER PHOTO: ST-B, ST-C, ST-H, ST-J FINAL SCOPE - REMOVE AND REPLACE 111.35 SF OF OAK FLOORING. STAIN AND SEAL

- ST-8 225.86 SF OF 1/2" HARDWOOD BEAD BOARD WALL PANELING, WATER, AND MOISTURE DAMAGE TO BEAD BOARD WALLS CREATING SWELLING AND MOLD SATURATION CAUSED BY WIND DRIVEN RAIN ENTERING THROUGH LOUVERS IN THE BELL TOWER PHOTO: ST-B, ST-G, ST-D, ST-E FINAL SCOPE - REMOVE AND REPLACE 225.86 SF OF 1X6 #2 PINE V GROOVE WALL, INCLUDING 2X CAP. STAIN AND SEAL

REMOVE AND REPLACE 1X6 #2 PINE V GROOVE WALL. STAIN AND SEAL

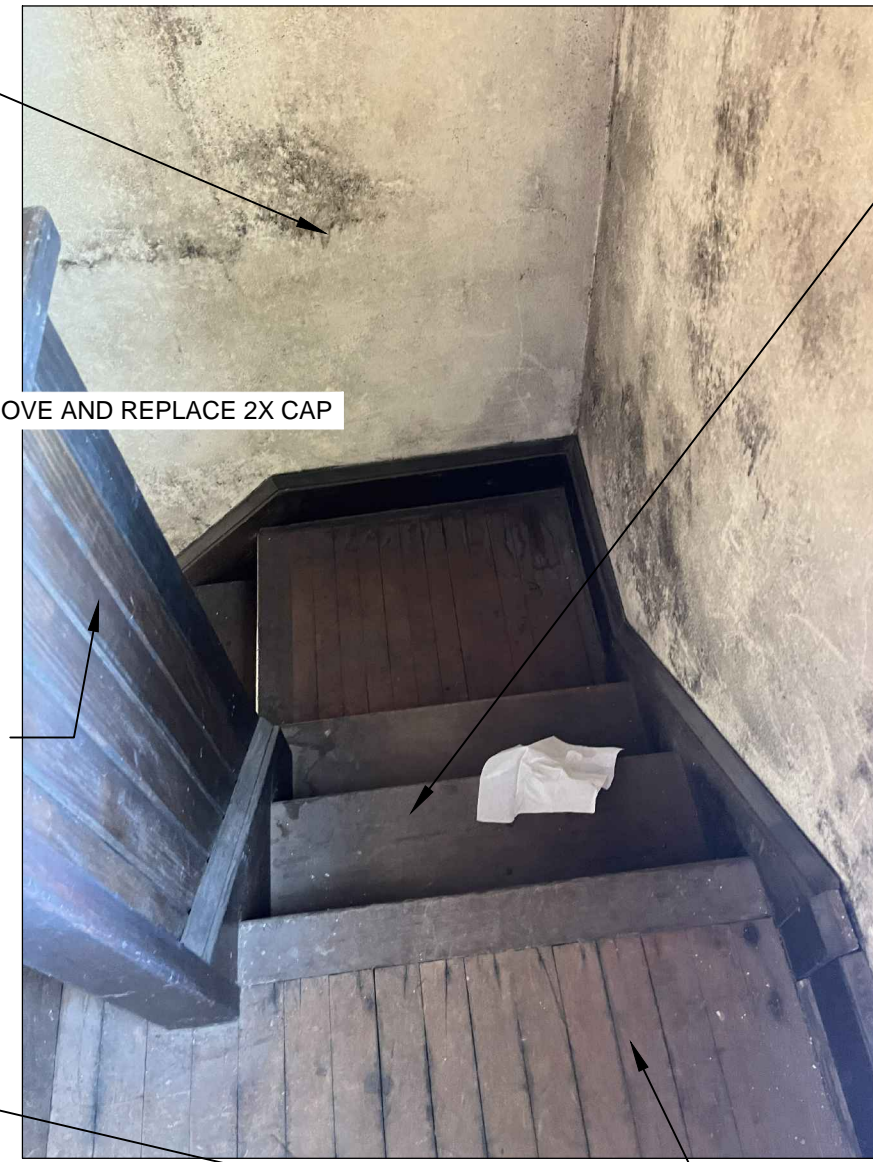
ST-C

- ST-1 17 STAIR TREADS 1' LONG X 2.5' WIDE, WATER AND MOISTURE DAMAGE TO STAIRS CAUSED BY WIND DRIVEN RAIN ENTERING THROUGH LOUVERS IN THE BELL TOWER PHOTO: ST-C, ST-D, ST-E FINAL SCOPE - SAND AND REFINISH 17 EACH OF 1' X 2.5' WIDE OF STAIR TREADS

REMOVE AND REPLACE 2X CAP

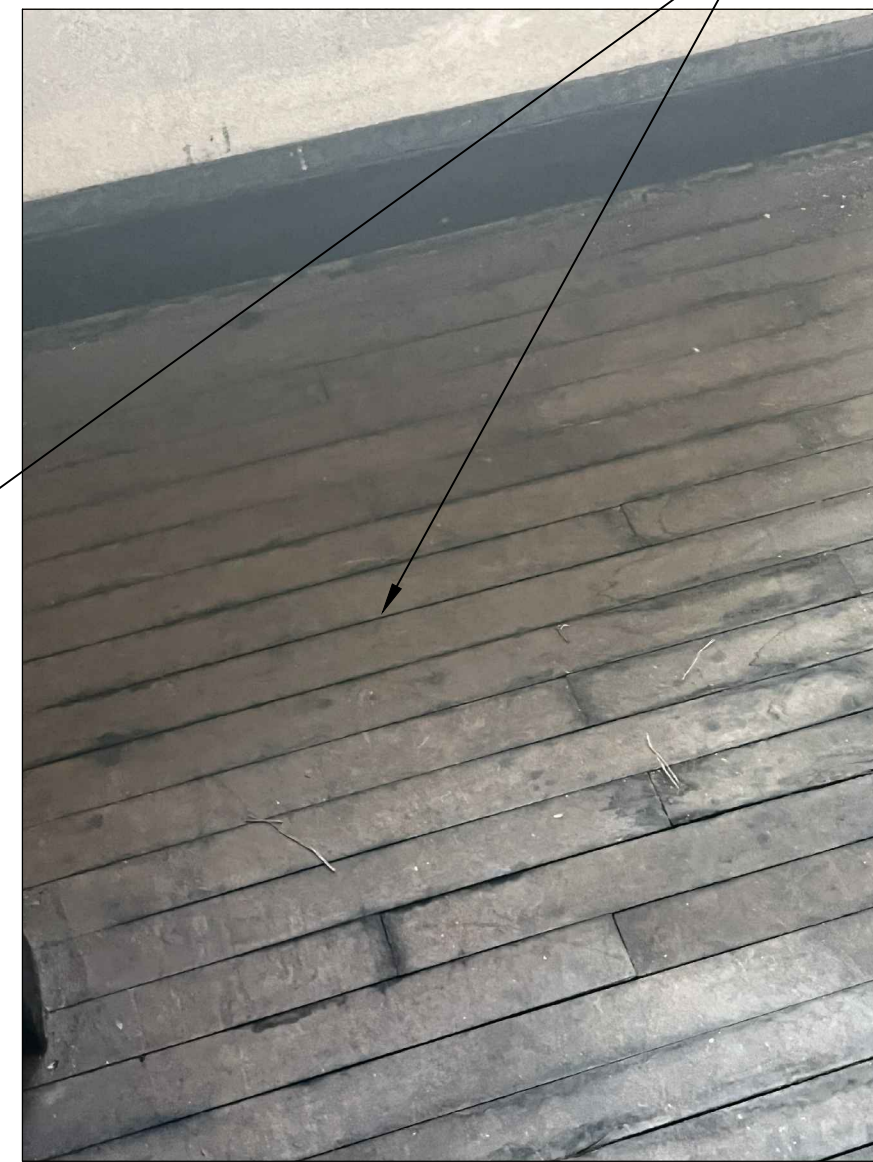
ST-H

- ST-6 8' HARDWOOD BASEBOARD (2 PIECES) 73.33 LF LONG, WATER AND MOISTURE DAMAGE TO FLOOR CAUSED BY WIND DRIVEN RAIN ENTERING THROUGH LOUVERS IN THE BELL TOWER PHOTO: ST-H, ST-J FINAL SCOPE - REMOVE AND REPLACE 73.33 LF OF 8" HARDWOOD BASE (2 PIECES). STAIN AND SEAL

REPLACE OAK FLOORING STAIN AND SEAL

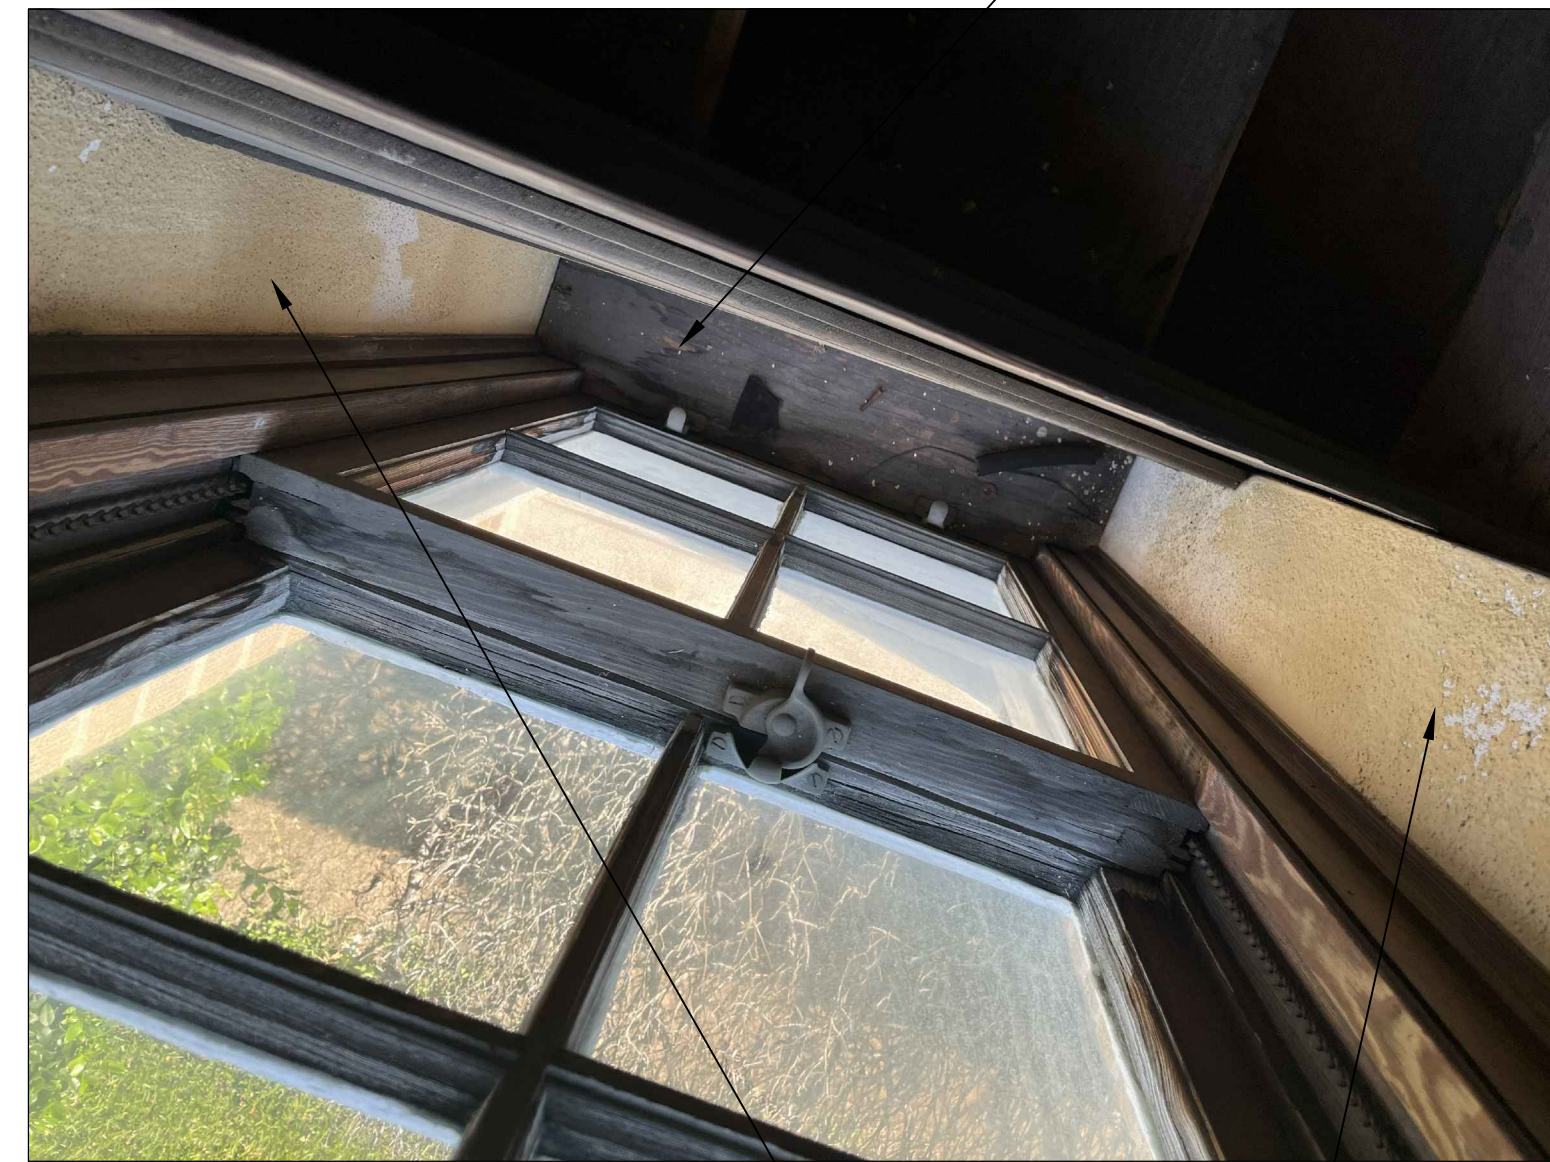
ST-K

- ST-10 WINDOW STOOL & APRON TRIM, 6.67 LF LONG, WATER AND MOISTURE DAMAGE TO WALLS CREATING SWELLING AND MOLD SATURATION OF TRIM CAUSED BY WIND DRIVEN RAIN ENTERING THROUGH LOUVERS IN THE BELL TOWER PHOTO: ST-K, ST-L FINAL SCOPE - REMOVE AND REPLACE 6.67 LF OF WINDOW STOOL AND APRON TRIM. STAIN AND SEAL

REMOVE AND REPLACE WINDOW STOOL AND APRON TRIM. STAIN AND SEAL

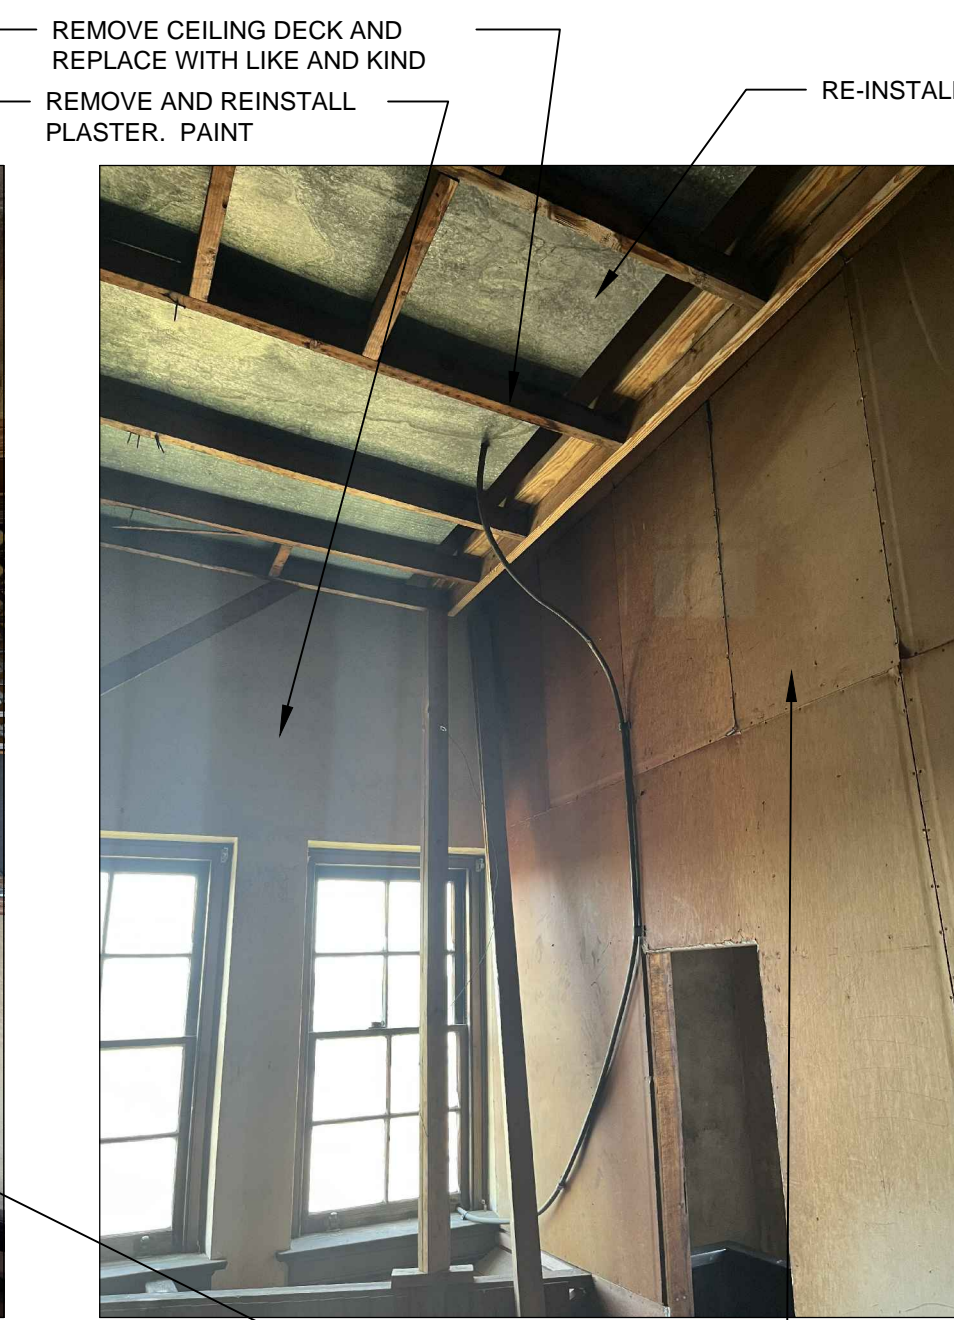
- SD-1 256 SF OF 1/2" THICK, 16' LONG X 16 FT HIGH, WATER AND MOISTURE DAMAGE TO WALL, WATER AND MOISTURE DAMAGE TO WALL BY WIND DRIVEN RAIN ENTERING THROUGH LOUVERS IN THE BELL TOWER. PHOTO: SD-A, SD-B FINAL SCOPE - REMOVE AND REPLACE 256 SF OF 1/2" FINISHED DRYWALL

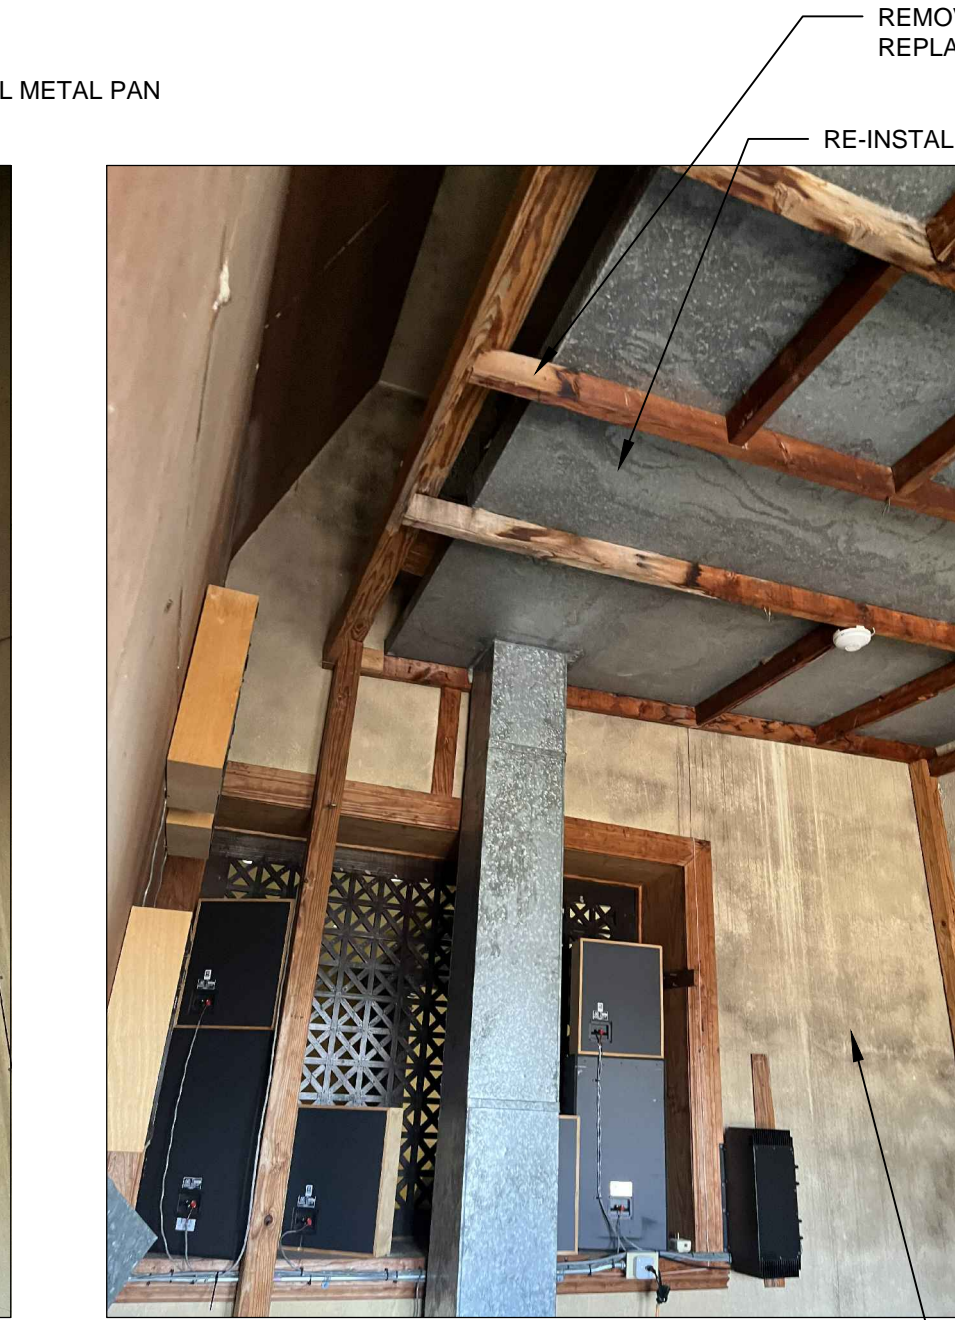
SD-C

- SD-4 624 SF OF PLASTER(3 COATS OVER METAL LATH) WALLS, (2 SIDES) 11.5' LONG X 16 FT HIGH AND 16' LONG X 16' HIGH, WATER AND MOISTURE DAMAGE TO WALLS CREATING MOLD AND PEELING PAINT CAUSED BY WIND DRIVEN RAIN ENTERING THROUGH LOUVERS IN THE BELL TOWER PHOTO: SD-C, SD-D, SD-E, SD-F, SD-G, SD-H, SD-J FINAL SCOPE -REPLACE 624 SF OF PLASTER WALLS

- SD-5 624 SF OF PAINT WALLS, (2 SIDES) 11.5' LONG X 16 FT HIGH AND 16' LONG X 16' HIGH, WATER AND MOISTURE DAMAGE TO WALLS CREATING MOLD AND PEELING PAINT CAUSED BY WIND DRIVEN RAIN ENTERING THROUGH LOUVERS IN THE BELL TOWER PHOTO: SD-C, SD-D, SD-E, SD-F, SD-G, SD-H, SD-J FINAL SCOPE - PAINT 624 SF WALL

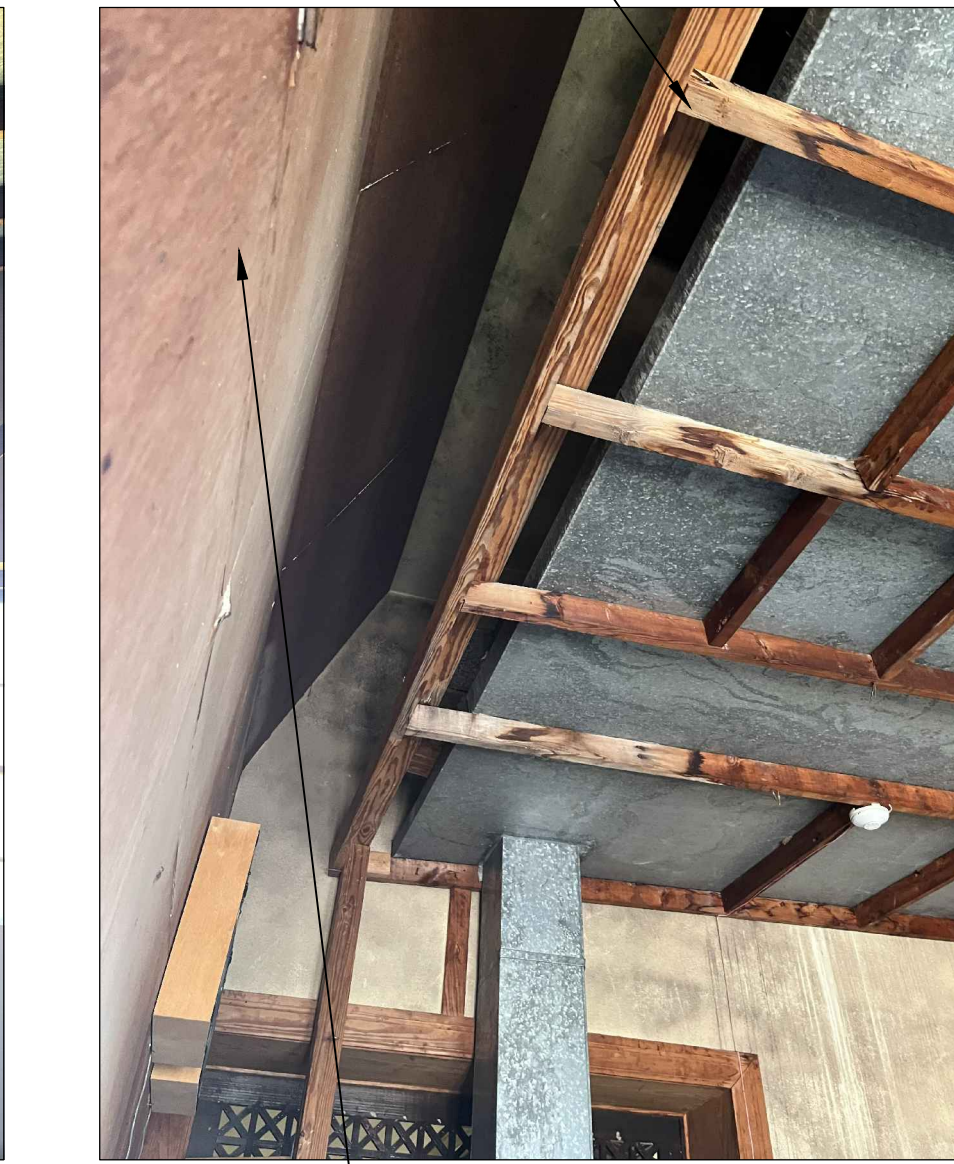
SD-H

- SD-2 184 SF OF PLASTER(3 COATS OVER METAL LATH) CEILING, 16' LONG X 11.5' WIDE, WATER AND MOISTURE DAMAGE TO CEILING CREATING MOLD AND PEELING PAINT CAUSED BY WIND DRIVEN RAIN ENTERING THROUGH LOUVERS IN THE BELL TOWER. PHOTO:SD-H FINAL SCOPE - REMOVE AND REPLACE 184 SF OF PLASTER CEILING

- SD-3 184 SF OF PAINT CEILING, 16' LONG X 11.5' WIDE, WATER AND MOISTURE DAMAGE TO CEILING CREATING MOLD AND PEELING PAINT CAUSED BY WIND DRIVEN RAIN ENTERING THROUGH LOUVERS IN THE BELL TOWER. PHOTO:SD-H FINAL SCOPE - PAINT 184 SF OF CEILING

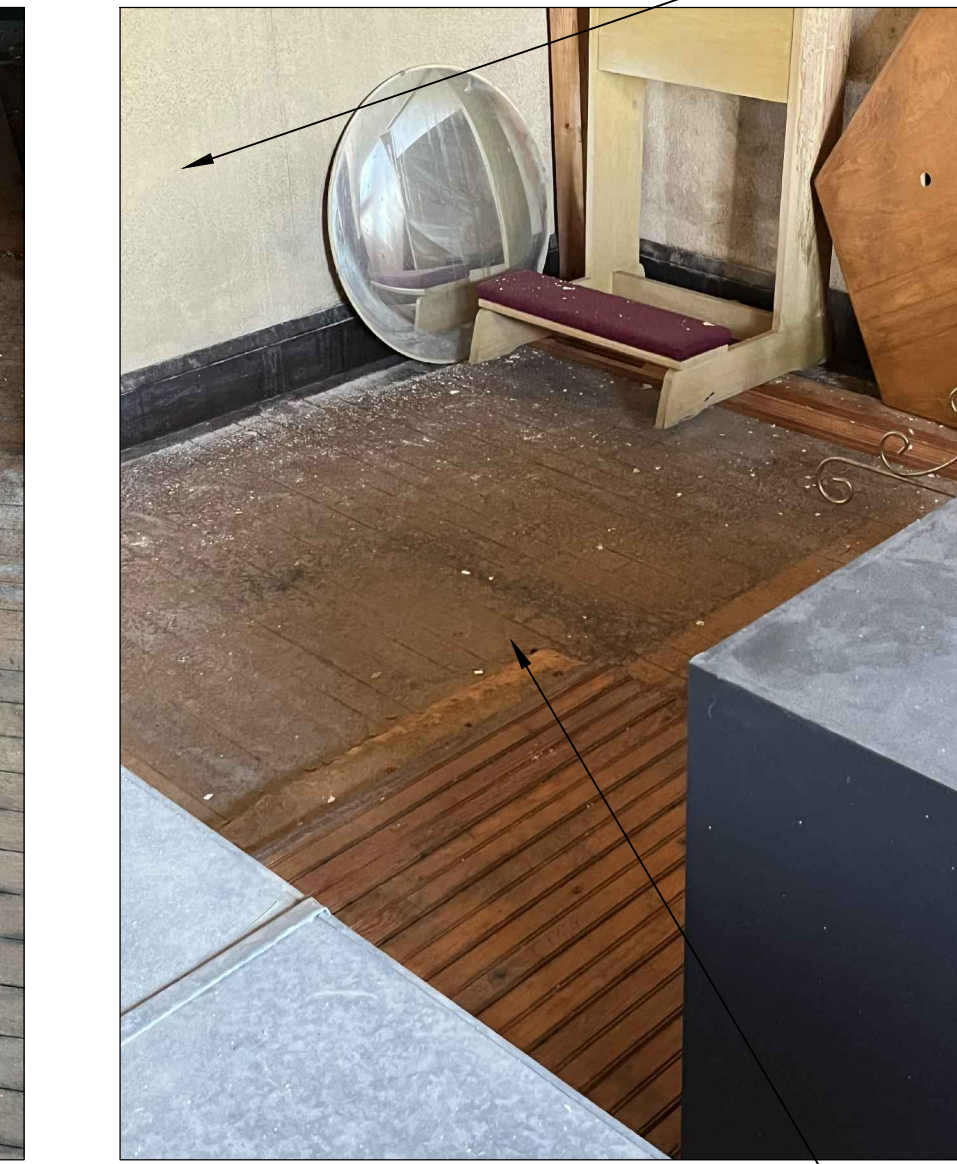
SD-L

- SD-6 184 SF OF OAK FLOORING, 11.5' LONG X 16' WIDE, WATER AND MOISTURE DAMAGE TO FLOORING CAUSED BY WIND DRIVEN RAIN ENTERING THROUGH LOUVERS IN THE BELL TOWER. PHOTO: SD-K, SD-L, SD-M, SD-N FINAL SCOPE - REMOVE AND REPLACE 184 SF OF OAK FLOORING. STAIN AND SEAL.

- SD-7 8" HARDWOOD BASEBOARD (2 PIECES) 55' LF LONG, WATER AND MOISTURE DAMAGE TO BASE CAUSED BY WIND DRIVEN RAIN ENTERING THROUGH LOUVERS IN THE BELL TOWER. PHOTO: SD-L, SD-M FINAL SCOPE - REMOVE AND REPLACE 55 LF OF 8" HARDWOOD BASE BOARD (2 PIECES) STAIN AND SEAL.
