ST JAMES FEMA REPAIRS

3617 GULFWAY DRIVE

DRAWINGS SHEET TITLE
COVER SHEET

DRAWINGS SHEET TITLE	FIRST FLOOR PLAN - MAIN BUILDING
SHEET NUMBER	A101
PROJECT NUMBER	21074

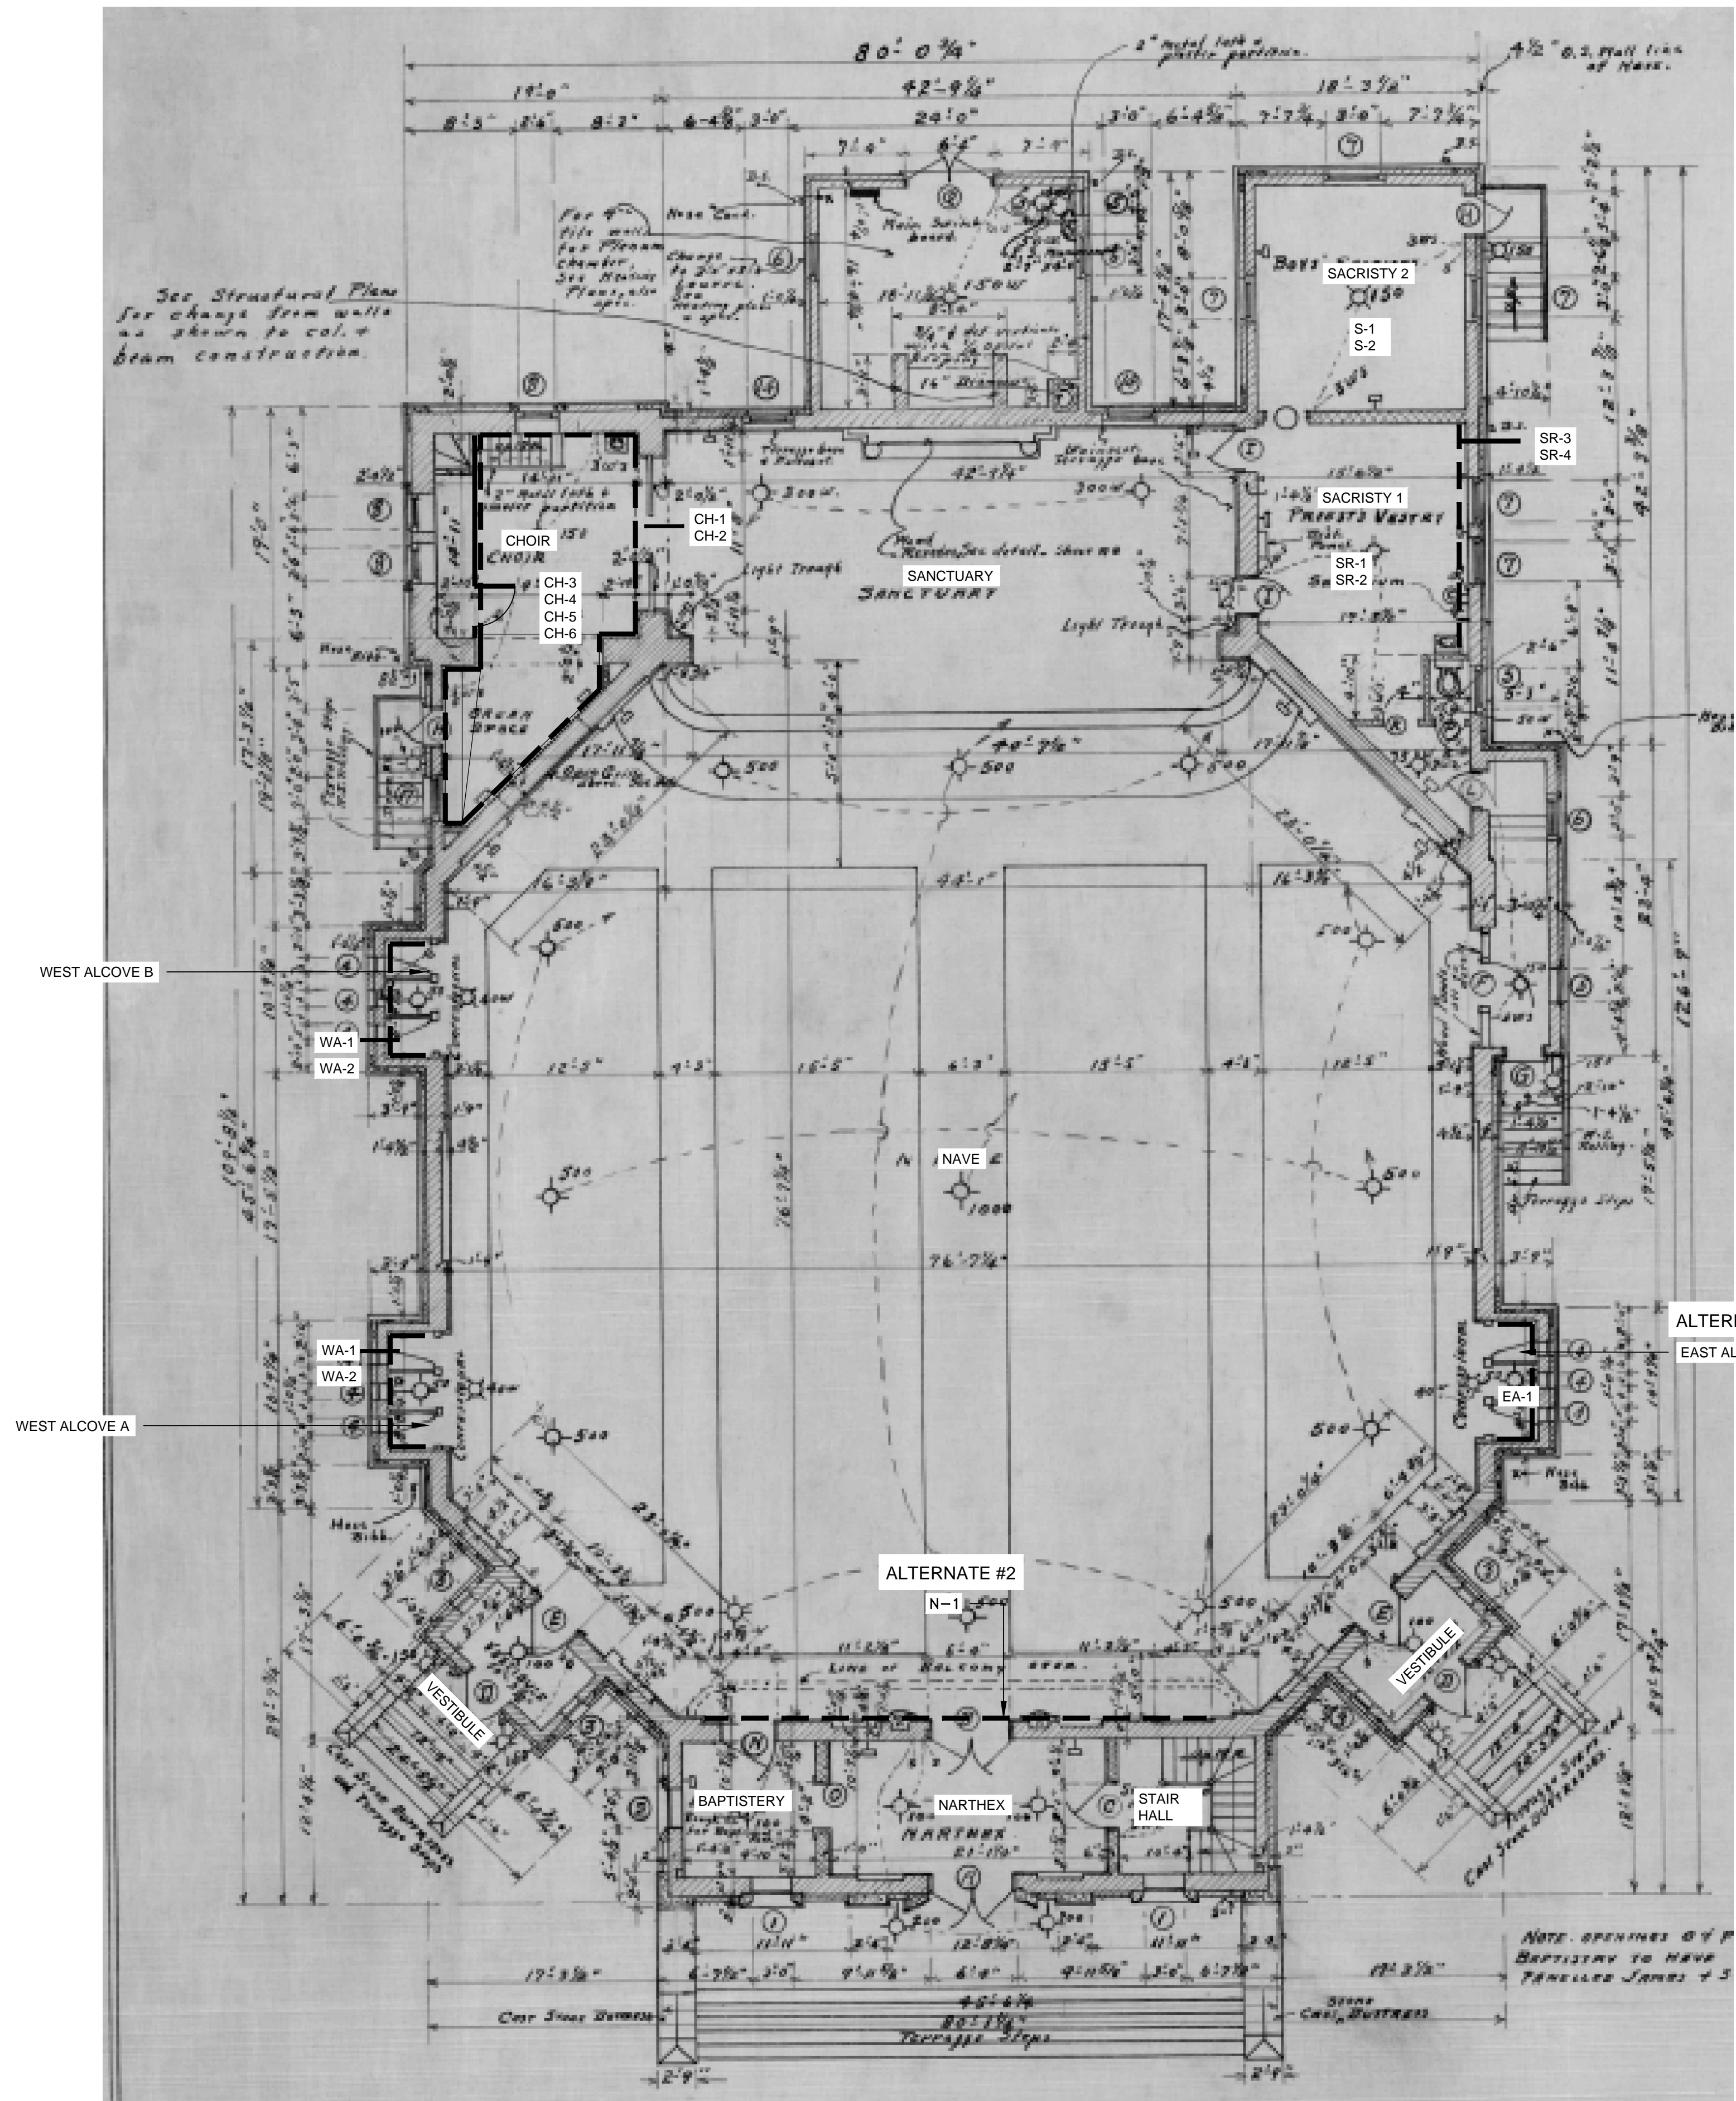
1 FIRST FLOOR PLAN - MAIN BUILDING
 SCALE: 1/8" = 1'-0"

- CH-1 690 SF OF PLASTER WALLS, 65.24' LONG X 10.58' HIGH, WATER AND MOISTURE WATER AND MOISTURE DAMAGE TO WALLS CREATING MOLD AND PEELING PAINT CAUSED BY WIND DRIVEN RAIN ENTERING THROUGH LOUVERS ON THE BELL TOWER
 PHOTO: CH-A
 FINAL SCOPE - REMOVE AND REPLACE 690 SF OF PLASTER WALL

- CH-2 690 SF OF PAINT WALLS 65.24' LONG X 10.58' HIGH, WATER AND MOISTURE WATER AND MOISTURE DAMAGE TO WALLS CREATING MOLD AND PEELING PAINT CAUSED BY WIND DRIVEN RAIN ENTERING THROUGH LOUVERS ON THE BELL TOWER
 PHOTO: CH-A
 FINAL SCOPE - PAINT WALLS

- CH-3 370 SF OF PLASTER CEILING, 17.58' LONG X 13.42' WIDE, + 13.38' LONG X 10' WIDE, WATER AND MOISTURE WATER AND MOISTURE DAMAGE TO WALLS CREATING MOLD AND PEELING PAINT CAUSED BY WIND DRIVEN RAIN ENTERING THROUGH LOUVERS ON THE BELL TOWER
 PHOTO: CH-B, CH-C, CH-F
 FINAL SCOPE - REMOVE ENTIRE PLASTER CEILING AND REPLACE WITH NEW.

- CH-4 370 SF OF COMMERCIAL CARPET AND PAD, 17.58' X 31.42 AND WIDE X 13.38' LONG X 10' WIDE, WATER AND MOISTURE DAMAGE TO FLOORING CAUSED BY WIND DRIVEN RAIN ENTERING THROUGH LOUVERS ON THE BELL TOWER
 PHOTO: CH-D, CH-E
 FINAL SCOPE - CARPET HAS BEEN REMOVE BY OWNER INSTALL NEW COMMERCIAL CARPET.

- CH-6 370 SF OF PAINT CEILING, 17.58' LONG X 10.58' HIGH, WATER AND MOISTURE WATER AND MOISTURE DAMAGE TO WALLS CREATING MOLD AND PEELING PAINT CAUSED BY WIND DRIVEN RAIN ENTERING THROUGH LOUVERS ON THE BELL TOWER
 PHOTO: CH-B, CH-C, CH-F
 FINAL SCOPE - PAINT ENTIRE PLASTER CEILING

- WA-1 288 SF OF PLASTER, 8' LONG 4' WIDE X 7' HIGH WATER AND MOISTURE DAMAGE TO WALLS AND CEILINGS CREATING MOLD AND PEELING PAINT CAUSED BY WIND AND DRIVEN RAIN LEAKING THROUGH ROOF
 PHOTO:ALCOVE A - WA-A, WA-B, WA-C
 PHOTO:ALCOVE B - WA-D, WA-E, WA-F
 FINAL SCOPE - REMOVE AND REPLACE 288 SF OF PLASTER WALLS AND CEILING IN ALCOVE
- WA-2 288 SF OF PAINT, 8' LONG 4' WIDE X 7' HIGH WATER AND MOISTURE DAMAGE TO WALLS AND CEILINGS CREATING MOLD AND PEELING PAINT CAUSED BY WIND AND DRIVEN RAIN LEAKING THROUGH ROOF
 PHOTO:ALCOVE A - WA-A, WA-B, WA-C
 PHOTO:ALCOVE B - WA-D, WA-E, WA-F
 FINAL SCOPE - PAINT WALLS AND CEILING.

- SR-1 347 SF OF PLASTER CEILING, 22.17' LONG X 15.67' WIDE, WATER AND MOISTURE DAMAGE TO CEILING CREATING MOLD AND PEELING PAINT CAUSED BY WIND DRIVEN RAIN LEAKING THROUGH ROOF
 PHOTO: SR-B, SR-C
 FINAL SCOPE - REMOVE AND REPLACE ENTIRE SF PLASTER CEILING

- SR-2 347 SF PAINT CEILING, 22.17' LONG X 15.67' WIDE, WATER AND MOISTURE DAMAGE TO CEILING CREATING MOLD AND PEELING PAINT CAUSED BY WIND DRIVEN RAIN LEAKING THROUGH ROOF
 PHOTO: SR-B, SR-C
 FINAL SCOPE - PAINT CEILING

- SR-3 160 SF OF PLASTER WALL, 16' LONG X 10' HIGH, WATER AND MOISTURE DAMAGE TO CEILING CREATING MOLD AND PEELING PAINT CAUSED BY WIND DRIVEN RAIN LEAKING THROUGH ROOF
 PHOTO: SR-A, SR-B
 FINAL SCOPE - REMOVE AND REPLACE 160 SF PLASTER WALL.

- SR-4 160 SF OF WALL PAINT, 16' LONG X 10' HIGH, WATER AND MOISTURE DAMAGE TO WALL CREATING MOLD AND PEELING PAINT CAUSED BY WIND DRIVEN RAIN LEAKING THROUGH ROOF
 PHOTO: SR-A, SR-B
 FINAL SCOPE - PAINT 160 SF OF WALL

- S-1 259 SF OF PLASTER CEILING, 16.5' LONG X 15.67' WIDE, WATER AND MOISTURE DAMAGE TO CEILING CREATING MOLD AND PEELING PAINT CAUSED BY WIND DRIVEN RAIN LEAKING THROUGH ROOF
 PHOTO: S-A, S-B, S-C, S-D, S-E, S-F
 FINAL SCOPE - REMOVE AND REPLACE ENTIRE PLASTER CEILING. REMOVE HVAC METAL DUCT, PAINT AND REINSTALL.
- S-2 259 SF OF PAINT CEILING, 16.5' LONG X 15.67' WIDE, WATER AND MOISTURE DAMAGE TO CEILING CREATING MOLD AND PEELING PAINT CAUSED BY WIND DRIVEN RAIN LEAKING THROUGH ROOF
 PHOTO: S-A, S-B, S-C, S-D, S-E, S-F
 FINAL SCOPE - PAINT CEILING

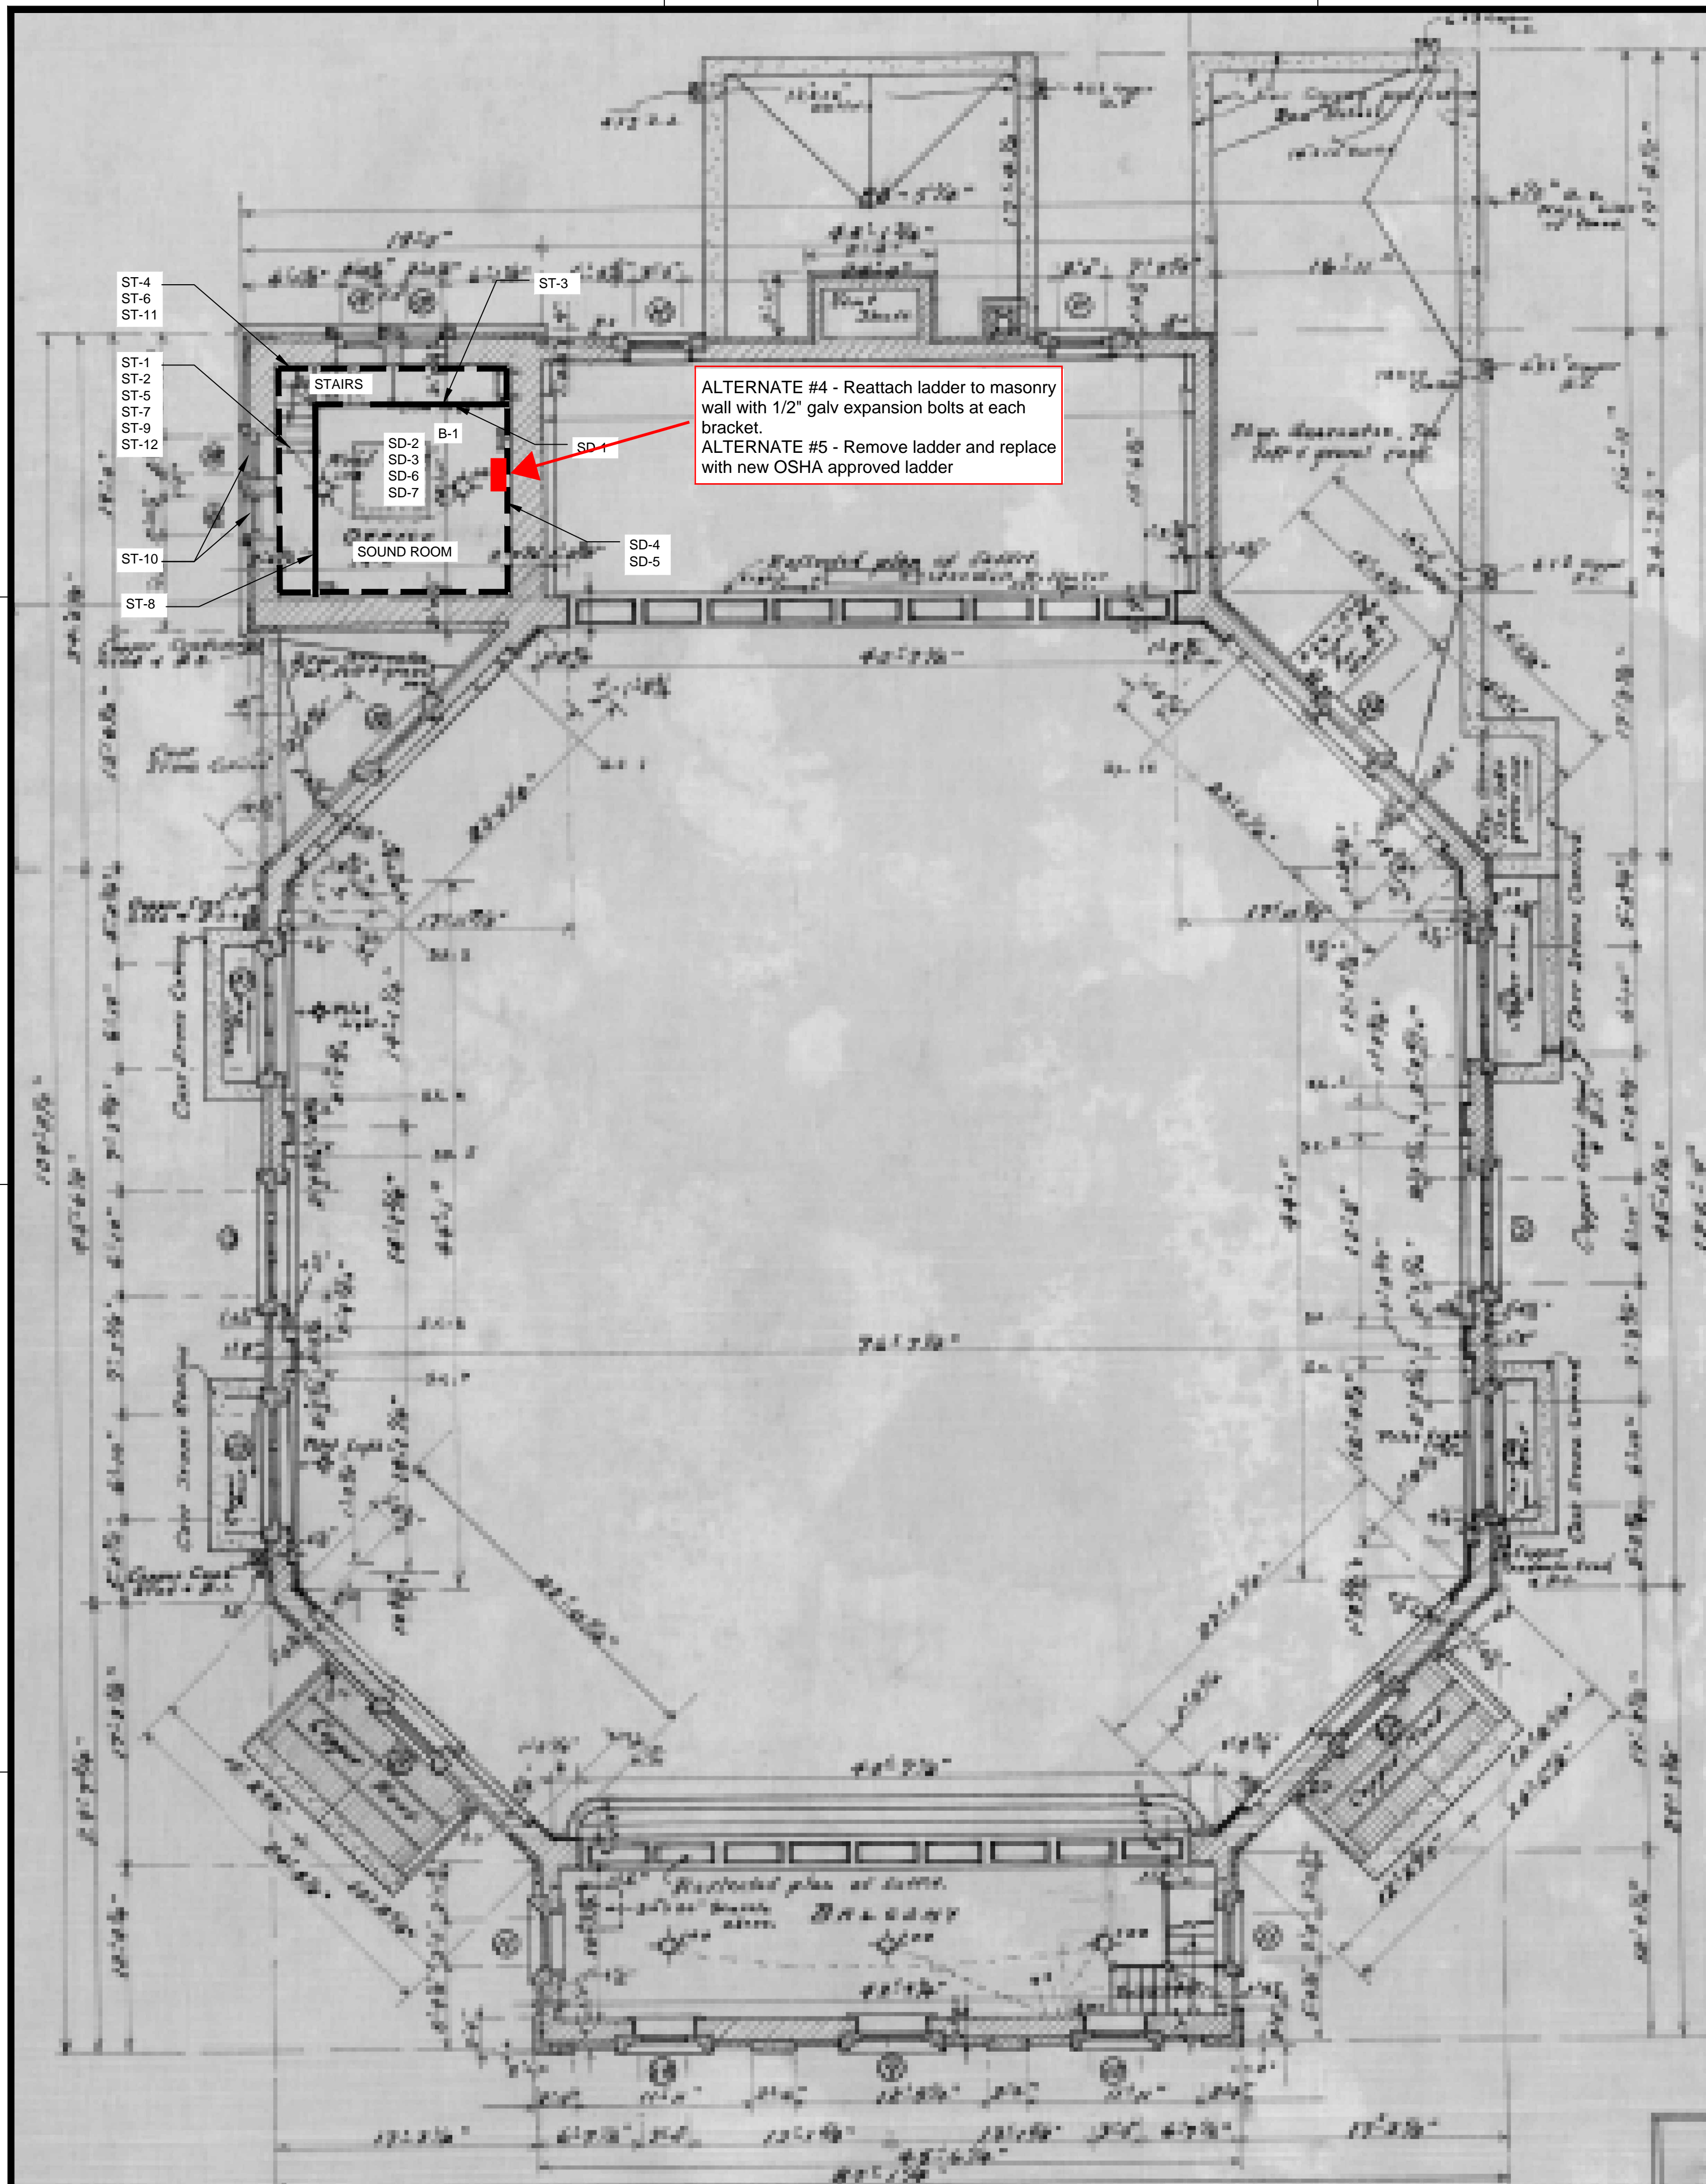
1 SECOND FLOOR PLAN - MAIN BUILDING
SCALE: 1/8" = 1'-0"

- ST-1 17 STAIR TREADS 1' LONG X 2.5' WIDE, WATER AND MOISTURE DAMAGE TO STAIRS CAUSED BY WIND DRIVEN RAIN ENTERING THROUGH LOUVERS IN THE BELL TOWER PHOTO: ST-C, ST-D, ST-E FINAL SCOPE - SAND AND REFINISH 17 EACH OF 1' X 2.5' WIDE OF STAIR TREADS

- ST-2 17 STAIR RISERS .75' LONG X 2.5' WIDE, WATER AND MOISTURE DAMAGE TO STAIRS CAUSED BY WIND DRIVEN RAIN ENTERING THROUGH LOUVERS IN THE BELL TOWER PHOTO: ST-E FINAL SCOPE - SAND AND REFINISH 17 EACH OF .75' X 2.5' WIDE STAIR RISERS

- ST-3 256 SF OF 1/2" THICK DRYWALL, 16' LONG X 16' HIGH, WATER AND MOISTURE DAMAGE TO WALL CAUSED BY WIND DRIVEN RAIN ENTERING THROUGH LOUVERS IN THE BELL TOWER PHOTO: ST-B, ST-G FINAL SCOPE - REMOVE AND REPLACE 256 SF OF 1/2" FINISHED DRYWALL

- ST-4 594.3 SF OF PLASTER (3 COATS OVER METAL LATH) WALLS (4 SIDES) 17.92' LONG X 10' HIGH + 4.17' LONG X 16' HIGH + 18.75' LONG X 16' HIGH + 2.42' LONG X 20' HIGH, WATER AND MOISTURE DAMAGE TO WALLS CREATING MOLD AND PEELING PAINT CAUSED BY WIND DRIVEN RAIN THROUGH LOUVERS IN THE BELL TOWER. PHOTO: ST-A, ST-B, ST-C, ST-F FINAL SCOPE - REMOVE AND REPLACE 294.3 SF OF PLASTER WALL

- ST-5 111.47 SF OF PLASTER (3 COAT OVER METAL LATH) CEILING (2 SIDES) 18.75' LONG X 4.17' WIDE + 13.75' LONG X 2.47 WIDE, WATER AND MOISTURE DAMAGE TO CEILING CREATING MOLD AND PEELING PAINT CAUSED BY WIND DRIVEN RAIN ENTERING THROUGH LOUVERS IN THE BELL TOWER FINAL SCOPE - REMOVE AND REPLACE 111.47 SF OF PLASTER CEILING.

- ST-6 8' HARDWOOD BASEBOARD (2 PIECES) 73.33 LF LONG, WATER AND MOISTURE DAMAGE TO FLOOR CAUSED BY WIND DRIVEN RAIN ENTERING THROUGH LOUVERS IN THE BELL TOWER PHOTO: ST-H, ST-J FINAL SCOPE - REMOVE AND REPLACE 73.33 LF OF 8" HARDWOOD BASE (2 PIECES). STAIN AND SEAL

- ST-7 111.35 SF OF OAK FLOORING - CLEAR GRADE, FLOORING, WATER AND MOISTURE DAMAGE TO FLOORING CAUSED BY WIND DRIVEN RAIN ENTERING THROUGH LOUVERS IN THE BELL TOWER PHOTO: ST-B, ST-C, ST-H, ST-J FINAL SCOPE - REMOVE AND REPLACE 111.35 SF OF OAK FLOORING. STAIN AND SEAL

- ST-8 225.86 SF OF 1/2" HARDWOOD BEAD BOARD WALL PANELING, WATER, AND MOISTURE DAMAGE TO BEAD BOARD WALLS CREATING SWELLING AND MOLD SATURATION CAUSED BY WIND DRIVEN RAIN ENTERING THROUGH LOUVERS IN THE BELL TOWER PHOTO: ST-B, ST-G, ST-D, ST-E FINAL SCOPE - REMOVE AND REPLACE 225.86 SF OF 1X6 #2 PINE V GROOVE WALL, INCLUDING 2X CAP. STAIN AND SEAL

- SD-3 184 SF OF PAINT CEILING, 16' LONG X 11.5' WIDE, WATER AND MOISTURE DAMAGE TO CEILING CREATING MOLD AND PEELING PAINT CAUSED BY WIND DRIVEN RAIN ENTERING THROUGH LOUVERS IN THE BELL TOWER. PHOTO:SD-H FINAL SCOPE - PAINT 184 SF OF CEILING

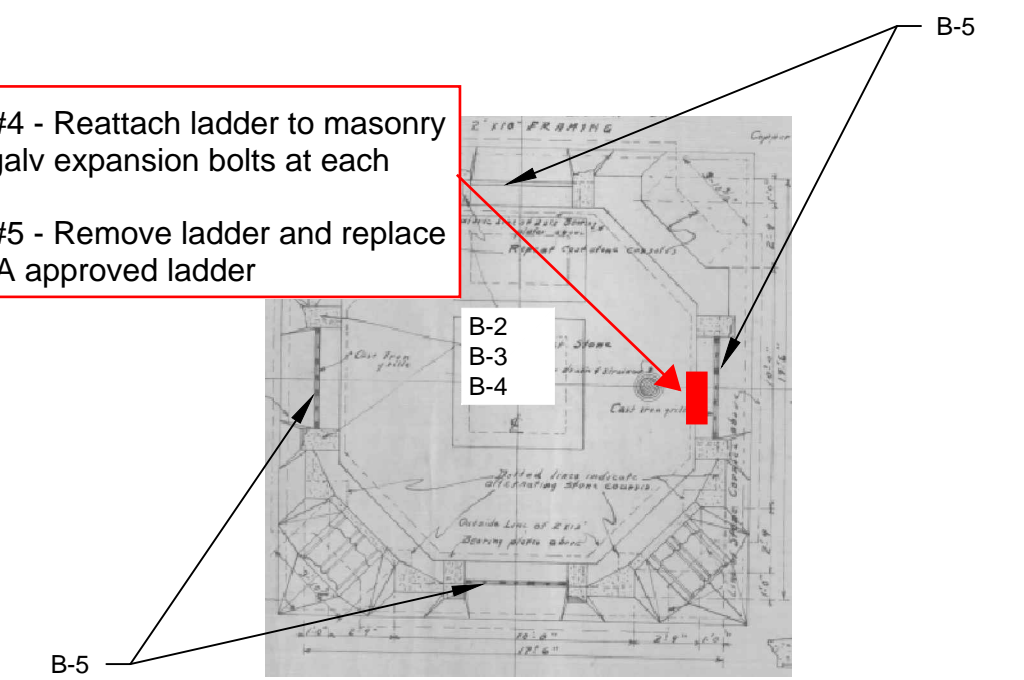
3 FIFTH FLOOR PLAN - BELFRY
SCALE: 1/8" = 1'-0"

(ALTERNATE #3)
B-5 REMOVE EXISTING LOUVERS
PHOTO: B-A, B-D, B-E
FINAL SCOPE - REPLACE LOUVERS WITH MIAMI DADE COUNTY QUALIFIED WIND-DRIVEN LOUVER. GREENHECK EHH-601D WITH STAINLESS STEEL INSECT SCREEN AND VCD-40 DAMPER. FLANGE/SLEEVE INSTALLATION. MILL FINISH

ALTERNATE #4 - Reattach ladder to masonry wall with 1/2" galv expansion bolts at each bracket.
ALTERNATE #5 - Remove ladder and replace with new OSHA approved ladder

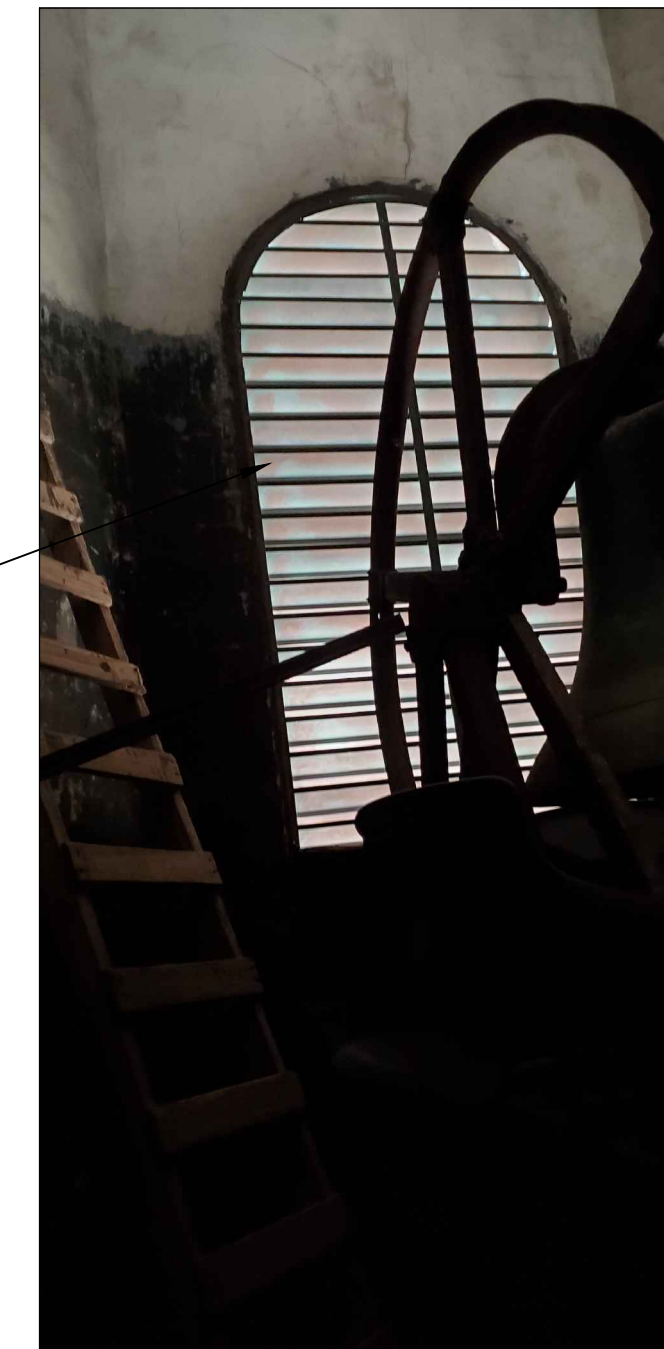
B-E

EXISTING LADDER. SEE ALTERNATES 4 & 5

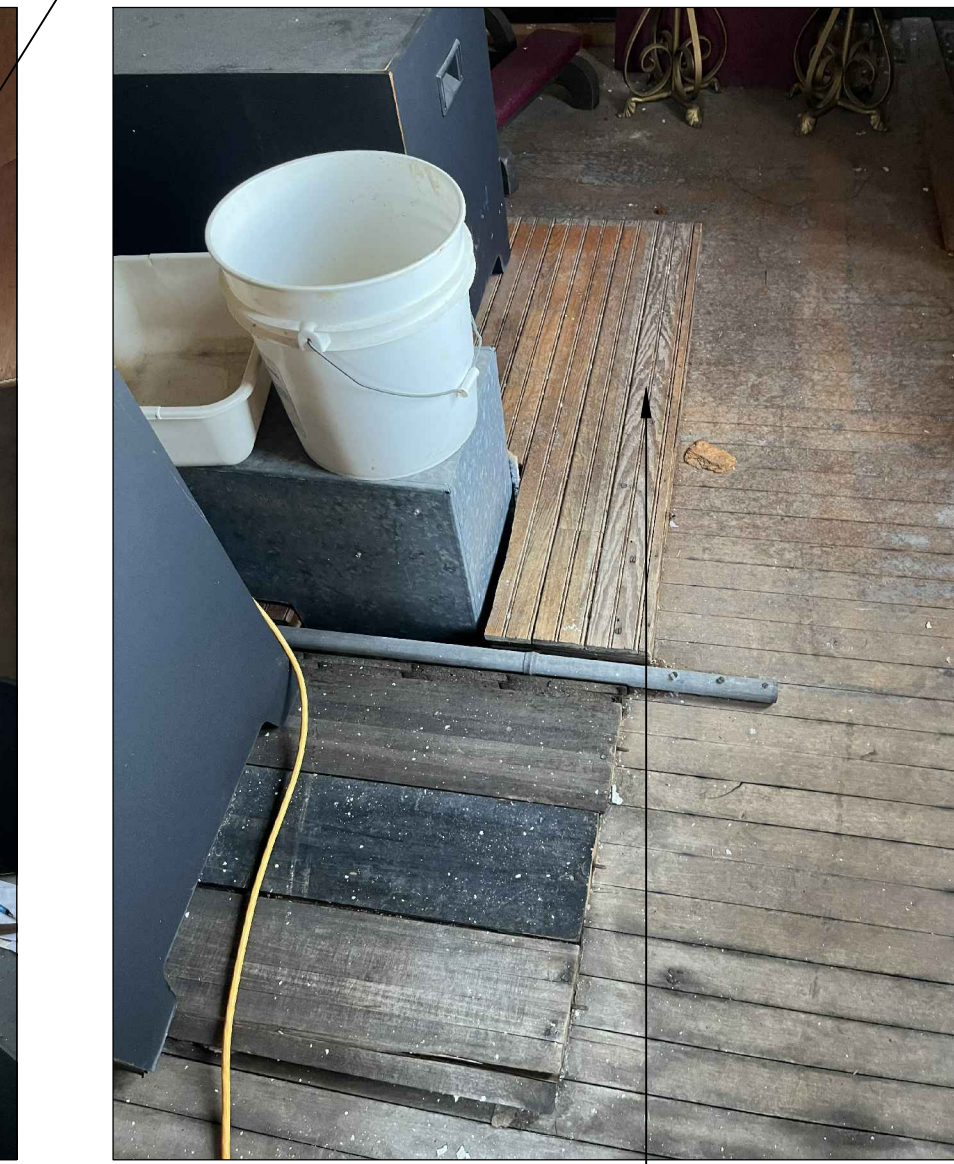
SD-K

- SD-6 184 SF OF OAK FLOORING, 11.5' LONG X 16' WIDE, WATER AND MOISTURE DAMAGE TO FLOORING CAUSED BY WIND DRIVEN RAIN ENTERING THROUGH LOUVERS IN THE BELL TOWER. PHOTO: SD-K, SD-L, SD-M, SD-N FINAL SCOPE - REMOVE AND REPLACE 184 SF OF OAK FLOORING. STAIN AND SEAL.

REMOVE OAK FLOORING. STAIN AND SEAL
